# **The 1928 St. Francis Dam Failure and Its Impact on American Civil Engineering**

*J. David Rogers*

## **THE 1928 ST. FRANCIS DAM DISASTER**

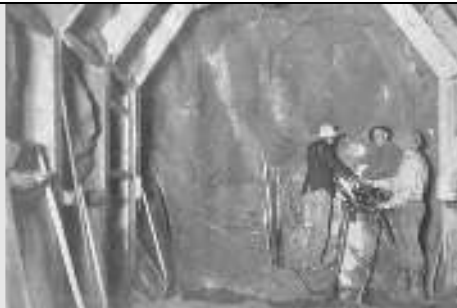
<p><b>The Elizabeth Lake Tunnel traversed the San Andreas fault at a depth of 400 feet in 1910. Mulholland recognized the threat posed by the fault to the city's aqueduct.</b></p>

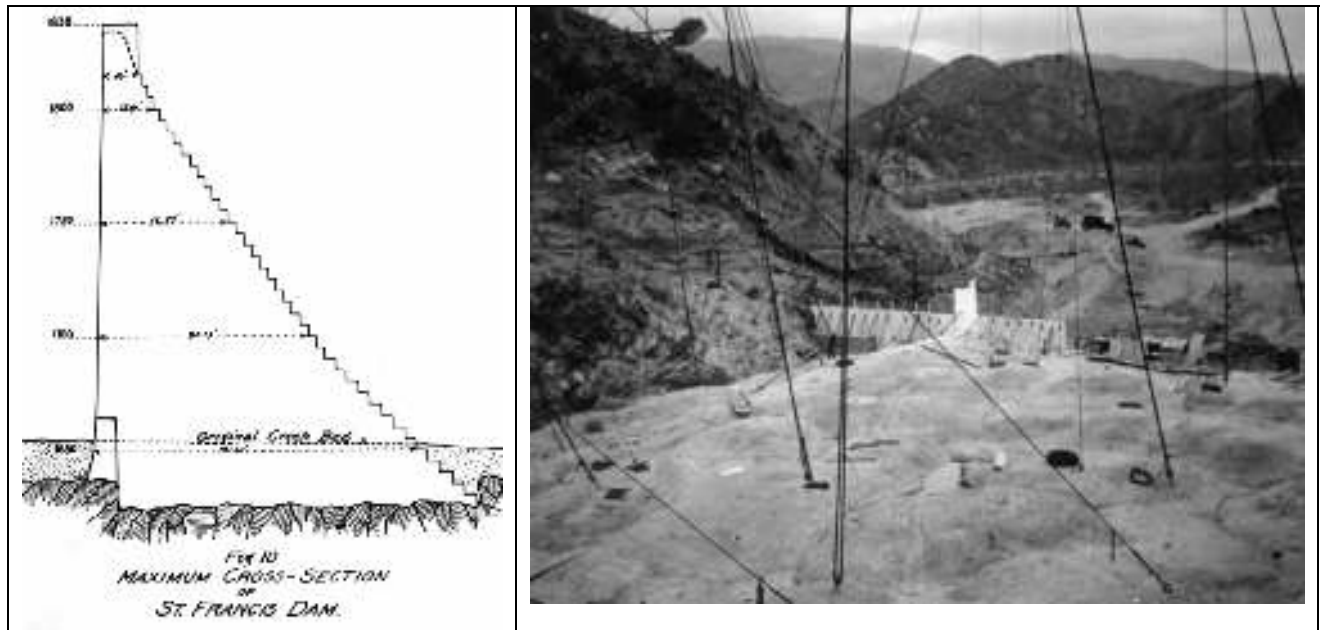
Figure 1 – The cofferdam across San Francisquito Creek is clearly seen in the photo at right, as well as the sketch at left, made by Carl Grunsky. Note the undulating “pillows” of concrete. No attempt was made to construct a through-going system of groutable contraction joints, nor was the concrete vibrated or the laitance layers jetted off the wet concrete while it set. As a consequence, the dam was constructed with an undulating series of semi-horizontal partings with low tensile strength. Both images from the Grunsky file in the St. Francis Dam Disaster Collection of the Huntington Library.

Since the perennial flow of the creek was so low, only a token cofferdam was afforded at the site, thus being incorporated into the heel of the main dam structure, at elevation 1638 (see Fig. 1). The alluvial materials (gravel and sand) were stripped from the channel and the bed of the exposed channel was excavated “about 8 feet,” according to Grunsky (1928). No record survives recording any attempt to explore the depth of channel fill ahead of actual construction, nor have any official as-built records ever been recovered. Contrary to many criticisms offered after its demise, the main dam section was afforded with uplift relief, in the form of 10 relief wells, shown in the upper portion of Fig.3. These were 15 to 30 feet deep. Like many non-federal masonry dams of that era (prior to 1928), it was not designed with a proper appreciation of uplift. The dam’s designers later testified that it was their belief the concrete was sufficiently impervious so as to remain essentially dry during its service life.

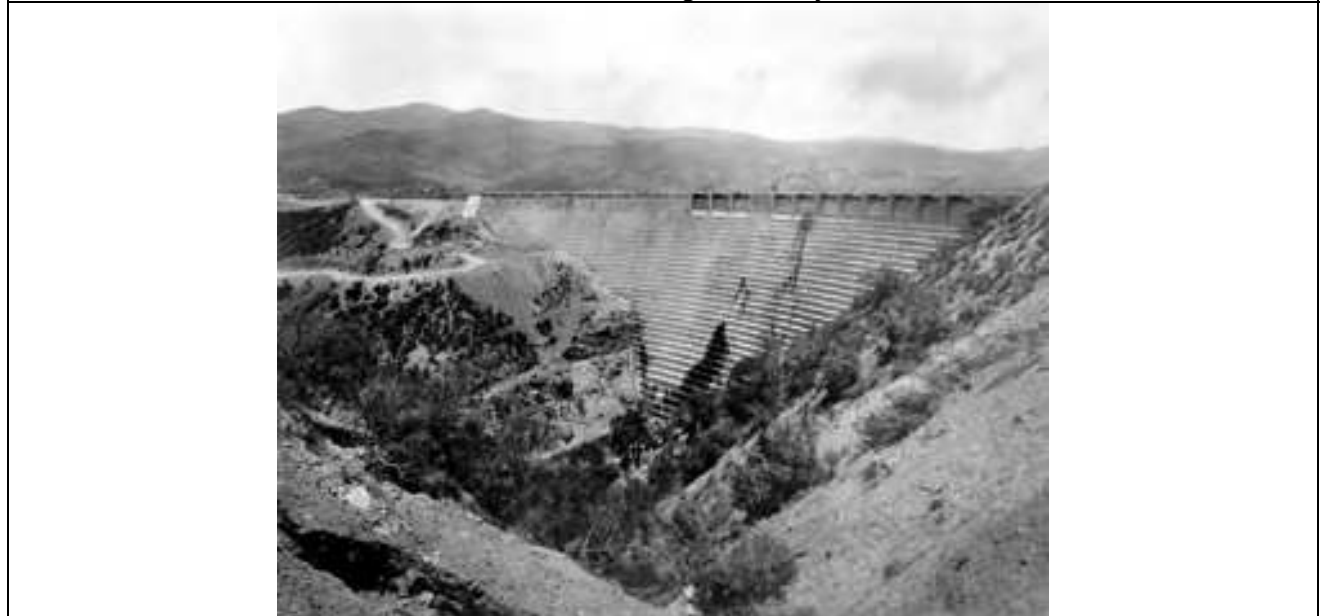
Figure 2 – St. Francis Dam as viewed from the old road, from the left abutment. The old access road with the 18% grade can be seen climbing the right abutment, below the dike. This was where the ‘muddy water’ was observed by damkeeper Harnishfaeger on the morning of the failure. Also note how it would be difficult to notice people with flashlights at the base of the dam’s left abutment, which cannot be seen from the old road.

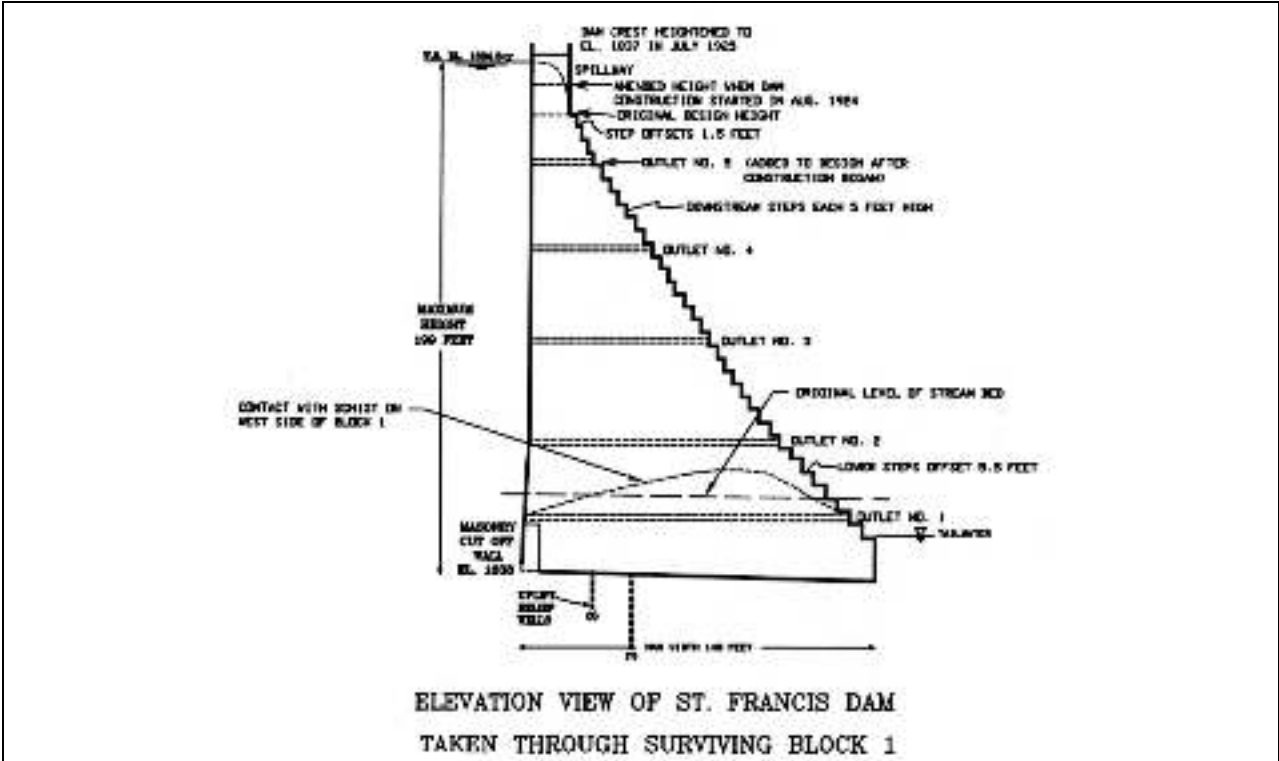
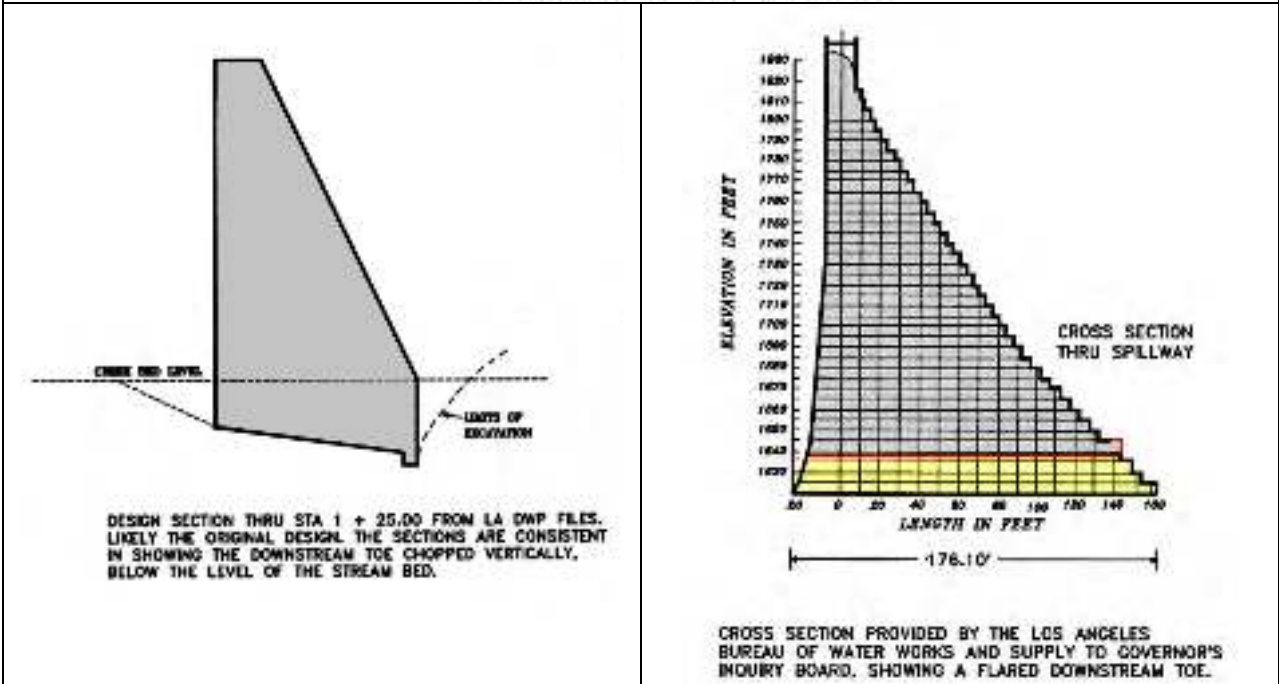
Figure 3. Comparisons between maximum cross sections of the St. Francis Dam. The upper section is what is believed to be fairly representative of the actual as-built conditions for the maximum cross section. The section at lower left is taken from the city's design files, showing the chopped base assumed in the 1923 design. The section at lower right was given to the Governor's Board of Inquiry by the city after the failure. Site photos suggest that that portion highlighted in yellow was never built, and that the maximum base width did not exceed 140 ft.

After St. Francis failed, BWWS presented the State Board of Inquiry with a standard cross section, reproduced in Fig. 3 - lower right. This section shows a battered upstream face commencing at elevation 1730, and increasing markedly, below elevation 1645, which would be considered good practice. From the photographs of Block 1 that survive, however, it is difficult

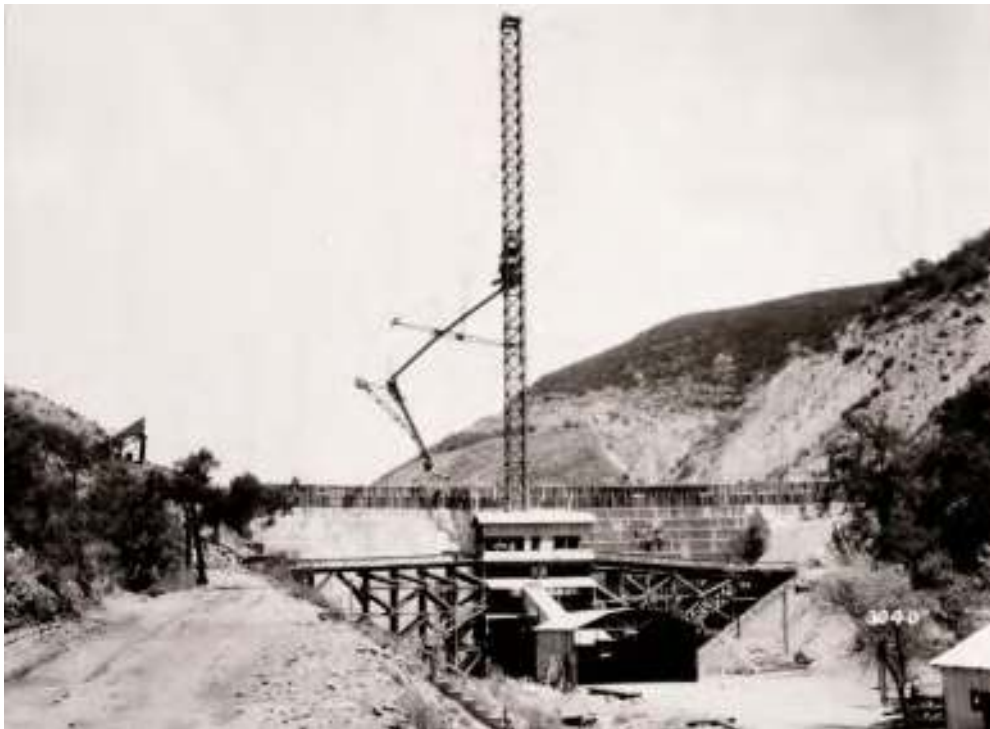
Figure 4 (upper). Upstream view of St. Francis Dam under construction, in the fall of 1924. The contractor’s concrete batch plant lies in front of the dam. The large shed in front of this structure was where aggregate collected down-canyon was end dumped into the plant. Photo from the Lippincott collection, U.C. Water Resources Center Archives.

A concrete batch plant was built in the canyon at the downstream toe of the dam (Fig.4) and local aggregate was incorporated with 1.12 barrels of Portland cement per cubic yard of concrete. The aggregate source was from the bed of San Francisquito Creek, between one-quarter and two miles downstream. The aggregate was neither washed nor graded, with the exception that cobbles greater than 6 inches were excluded, to permit the method of concrete delivery, seen in Figs. 4 thru 8. The decision not to wash the aggregate was a critical one, but was likely fostered by the relative paucity of water available at the site within San Francisquito Creek, which is dry much of the year. This same omission was made a year previous while constructing Hollywood (Mulholland) Dam.

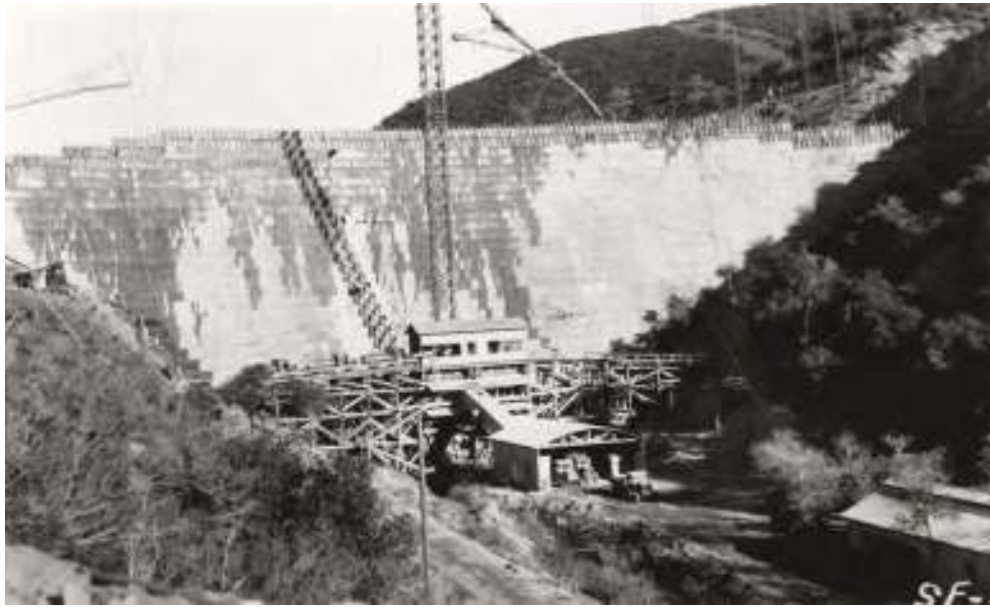
Figure 4 (Lower) - Same view as above, but about a year later, when the dam was nearing completion. Each of the steps were five feet high and forms can be seen along the upper three tiers. Note the dump trucks parked in the shed in front of the batch plant. Photo LA Dept of Water & Power.

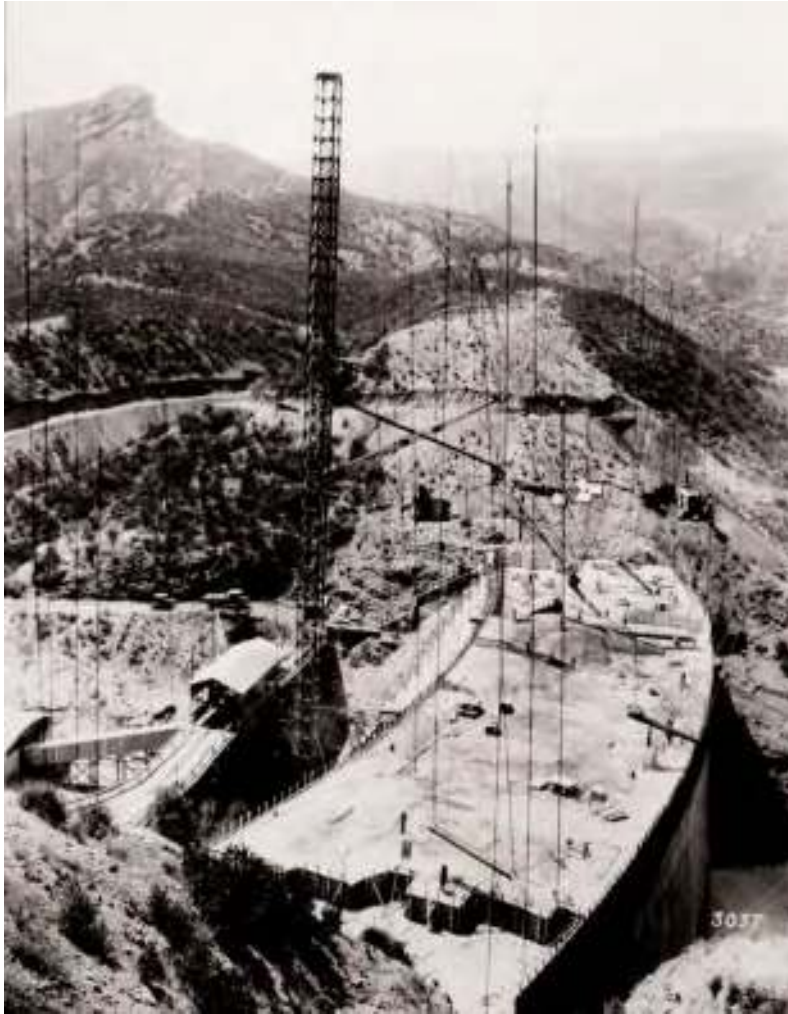
Figure 5. View looking northwest towards the left abutment, during the dam's construction, around March 1925. Shear key baffles are being placed within the dam, about 50 and 100 feet from either abutment. Note the steam shovel working on the right abutment and the contractor's tower, used to deliver concrete to the central dam area via a system of cables.

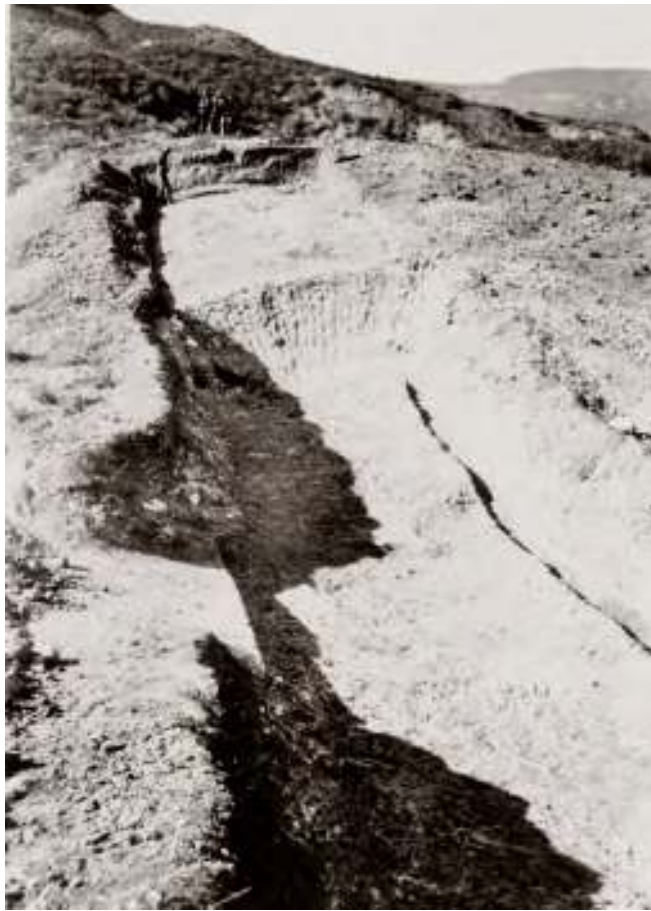
Figure 6. Keyway excavation in the Vasquez conglomerate cut by steam shovel for the dam's dike section, which extended about 600 feet northwest of the right abutment crest. Photo taken from Lippincott collection, U.C. Water Resources Center Archives.

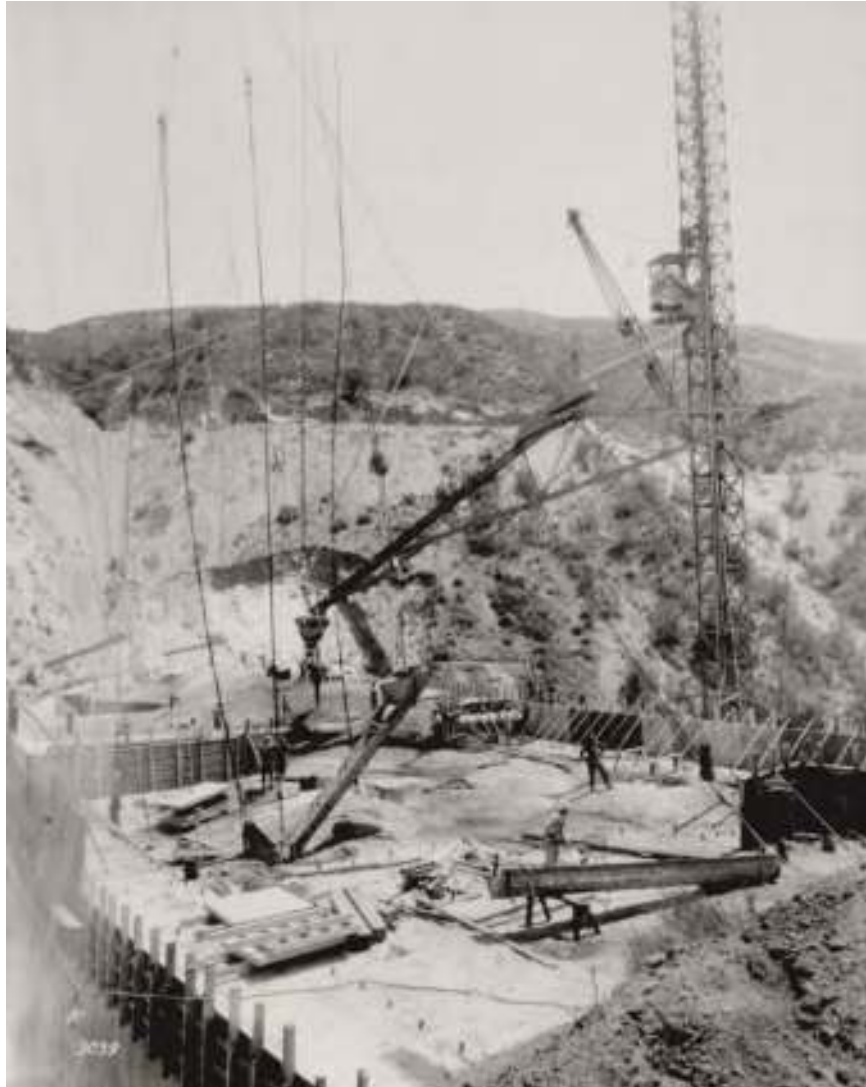
Figure 7. View looking west southwest towards the left abutment, in the Pelona Schist. Excavation of about 20 feet of schist can be seen, as well as the planar nature of the foliation surface, paralleling the abutment. Note the standing ponds of laitance moisture sitting upon the concrete pillows in foreground. Photo from L.A. Dept. of Water and Power.

Excavation into the schist on the left abutment was of similar scale, but appears to have extended about 15 to 20 feet, as suggested in Fig. 7. A cutoff trench (or shear key) about 3 by 3 feet was noted underneath some of the dam’s blocks displaced downstream after the failure (Fig. 32). With exception of the 10 uplift relief wells under the dam’s main section, the structure was bereft of any further seepage cutoff or control, such as deep cutoff walls, internal inspection galleries, seepage grout curtain beneath the dam, or uplift relief provided beneath the dam’s steeply sloping abutments. Many of these details of foundation preparation would gain industry-wide acceptance a decade later, after St. Francis failed.

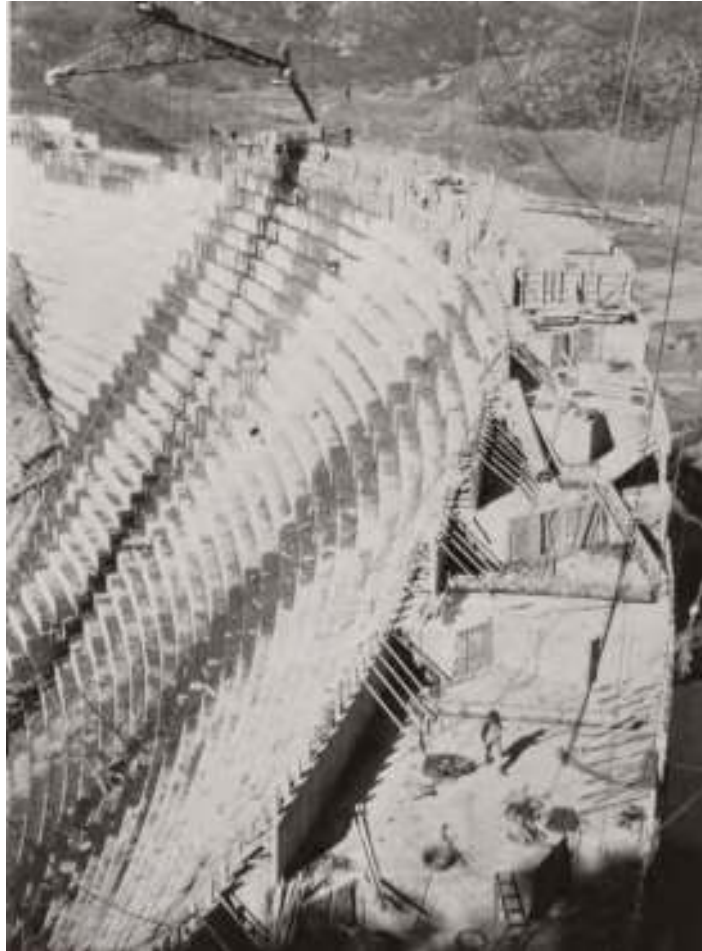
Figure 8. View of the main dam crest under construction, as seen from the left abutment crest. In this zone the shear key baffles were placed more frequently. Note how each step on the downstream face has a unique width, decreasing with upward elevation. Photo Lippincott Collection of U.C. Water Resources Center Archives.

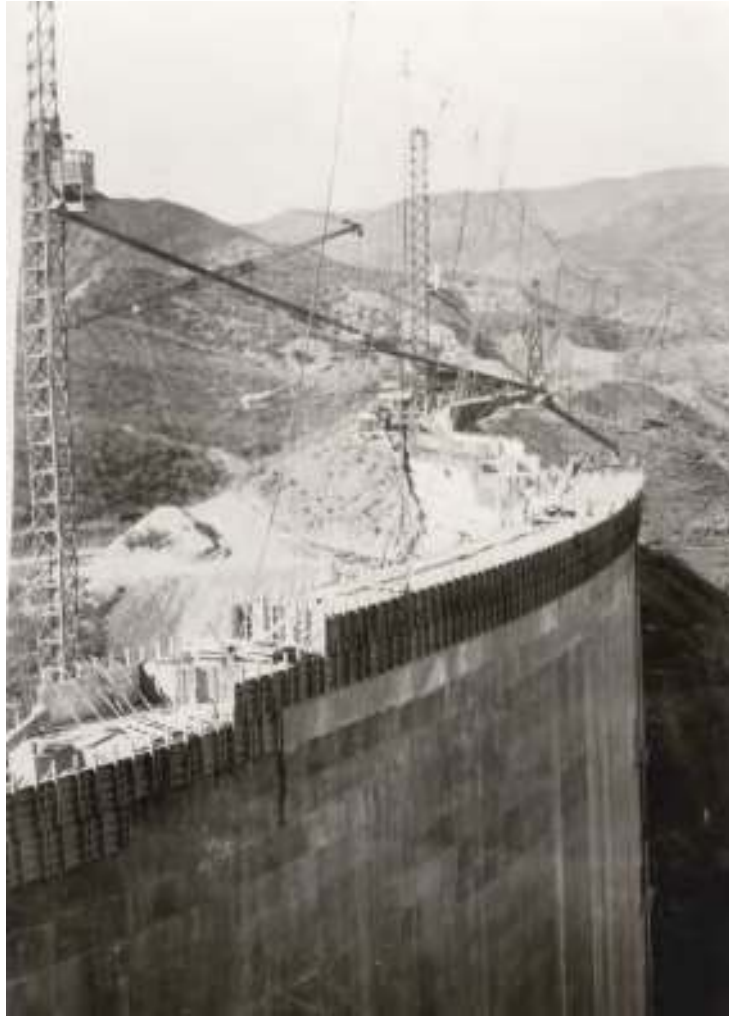
Figure 9. The dam design was amended to increase the overall height by 20 feet, taken in 10-foot increases on two occasions, a year apart. This view shows the dam topping out, sometime in 1926. The finished crest width was 16 feet. By this time the contractor was forced to install additional towers to aid in concrete placement along the dike section in the background. Photo from Lippincott Collection of U.C. Water Resources Center Archives.

As had occurred the previous July, in July 1925 the dam was heightened another 10 feet, increasing reservoir capacity to 38,168 acre feet, which coincided with Los Angeles' water consumption in 1924. This second raising of the dam structure, viewed in Fig. 9, necessitated extension of the wing dike some 600 feet northwest of the main dam's crest, requiring another 3,826 cubic yards of concrete. The contractor was forced to set up another lattice tower and wood derrick from which to suspend long troughs to direct concrete from the batch plant in the canyon bottom (Fig. 9). An auxiliary spillway was built across a natural saddle several hundred feet beyond this (Fig. 10). This saddle has since been excavated to accommodate the new alignment of San Francisquito Canyon Road north of the dam site. This second heightening would appear to have been most critical to the dam's subsequent structural stability, as discussed later.

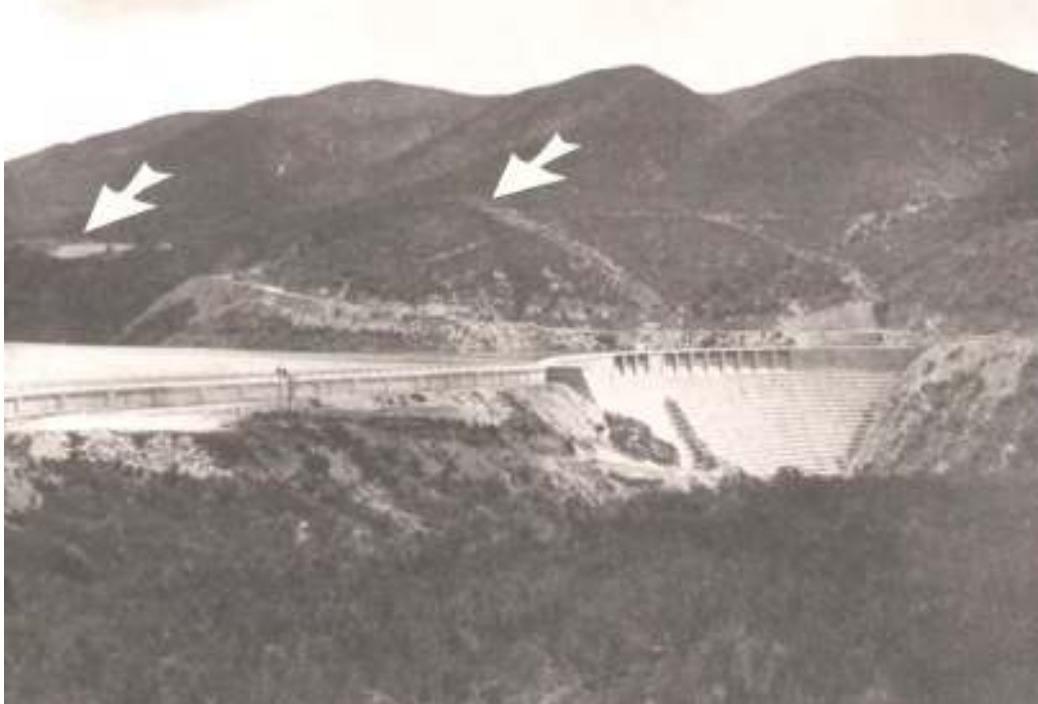
Figure 10 (upper). Part of a three photo panorama, believed to have been imaged in the spring of 1927, when the reservoir was about 20 feet below the spillway slits. Note the position of San Francisquito Canyon Road, cutting across the dam's left abutment, about 13 feet above crest. Also note the prominent terrace platforms exposed in the Pelona schist. Photo L.A. Dept. of Water & Power.

The building of the dam had necessitated construction of a new road between Powerhouses 1 and 2, about nine miles apart. This road was cut into the schist a point about 4,000 feet downstream of the dam, crossing the dam's left abutment about 13 feet above the dam's crest (Fig. 10). A foot path led down to the dam, which was 16 feet wide along its crest. In order to access the dam by vehicle, it was necessary to remain on a gravel road running along the canyon bottom, pass the damkeeper's residence about a quarter mile downstream of the dam, and ascend an old construction road with an 18% grade, climbing the ravine just below the right abutment. This old road led to the auxiliary spillway. From here, vehicles could be parked on a cut pad situated between the dike section and the auxiliary spillway (Fig. 10). This road became impassable during inclement weather and the decision had been made to grade a new road with more acceptable grades on the opposite side of the ravine, leading to the same location. This road was under construction when the dam failed, and traces of it can still be seen today.

Of great import are several facts, only briefly related here. There were several employees of Powerhouse 1 (upstream of the dam) who passed by the dam's left abutment (actually, slightly above the abutment, as seen in Fig. 10) within a few hours of the failure. One of these was the Ray Silvey family, who crossed by the dam between 8:30 and 9 PM on March 12th. Silvey was the Powerhouse 1 operator who went on shift at 11 PM, along with a Mr. Tate. Silvey later recalled crossing a crack about 12 inches high extending across the road, just upstream of the dam (see Outland, 1977, p. 234). Insofar as the road was completely upon cut in the Pelona schist (Fig. 11), this observation can only suggest incipient motion of a large bedrock landslide in close proximity of the dam's left abutment.

The many prominent terraces developed upon the Pelona escarpment (Fig. 10) can still be appreciated today (Figs. 42 and 43). As Willis deduced, these are not erosional terraces capped by terrace deposits, but colluvial-infilled headscarp grabens of enormous slump blocks, which slid upon the schist's micaceous foliation planes; just like the 1928 east abutment slide, but much larger. A landslide map created by the author and the late Perry Ehlig (see sidebar) is presented as Fig. 46.

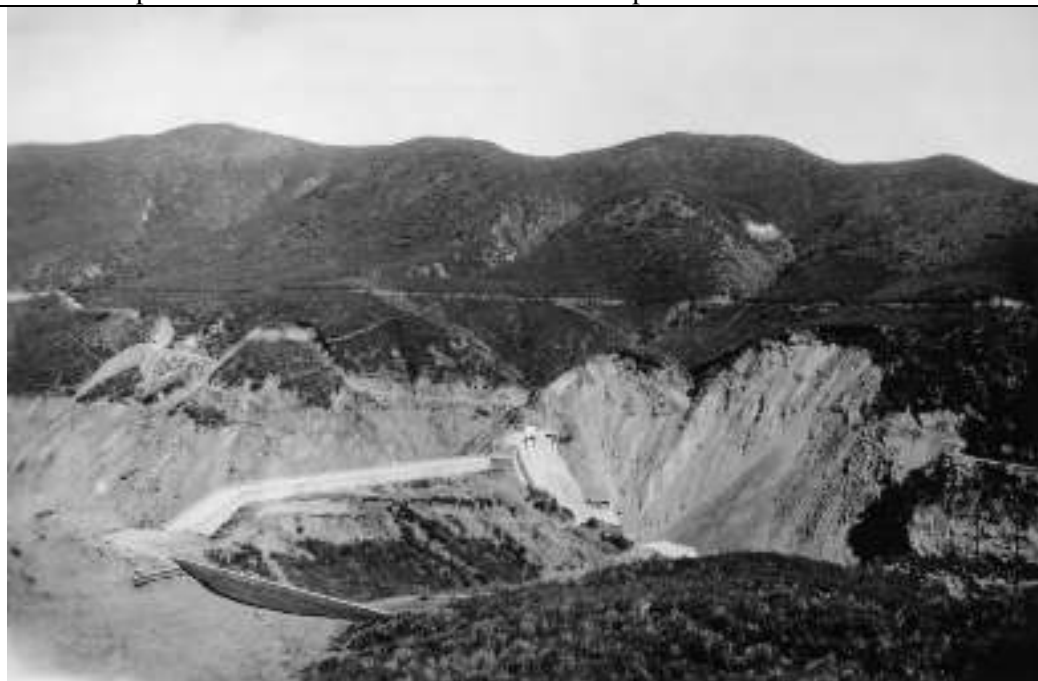
Figure 10 (lower). Same view taken after the failure. Note the prominent topographic bench in the Sierra Pelona escarpment, caused by massive landslipping. The east abutment slide is at right center. Another slump is obvious at left center, which dropped the old San Francisquito Cyn. Rd. about 50 feet (profiled in Fig. 45). From La Rue Collection at the Huntington Library.

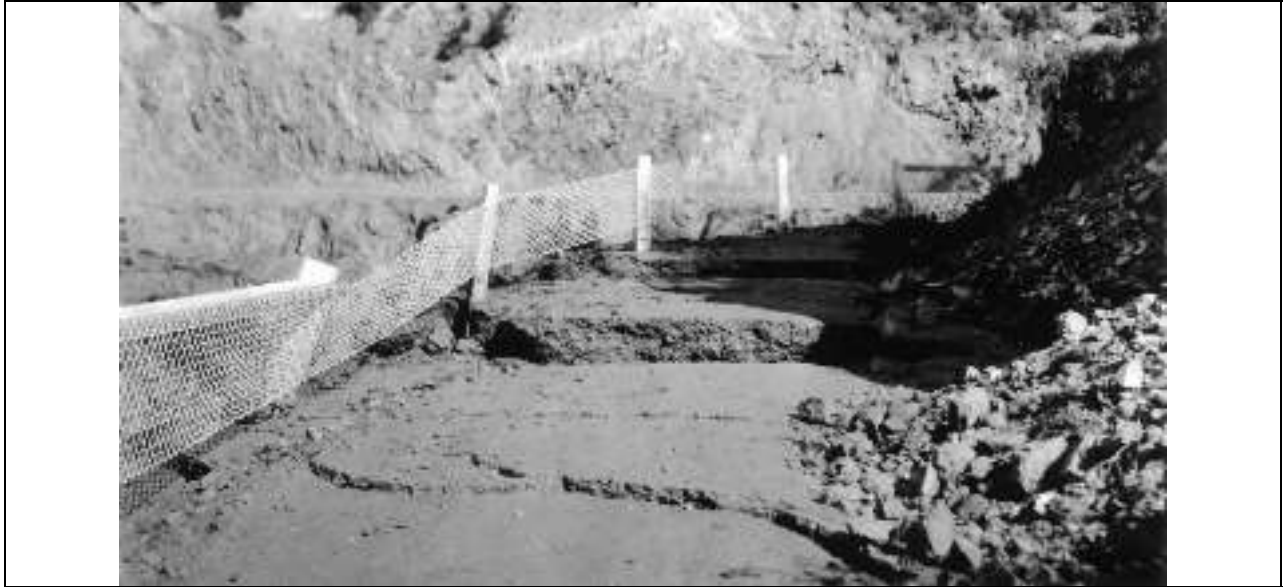
Fig. 11 - En-echelon tension cracks in San Francisquito Canyon Road several hundred feet upstream and about 20 feet above the dam's left abutment. The Ray Silvey family noted that one of these scarps was 12 inches high when they passed the dam between 8:30 and 9 PM, forcing them to stop their car and excavate ramps for their tires. These scarps were developed in the Pelona Schist. Photo by Bailey Willis, from the St. Francis Dam Disaster Collection at the Huntington Library.

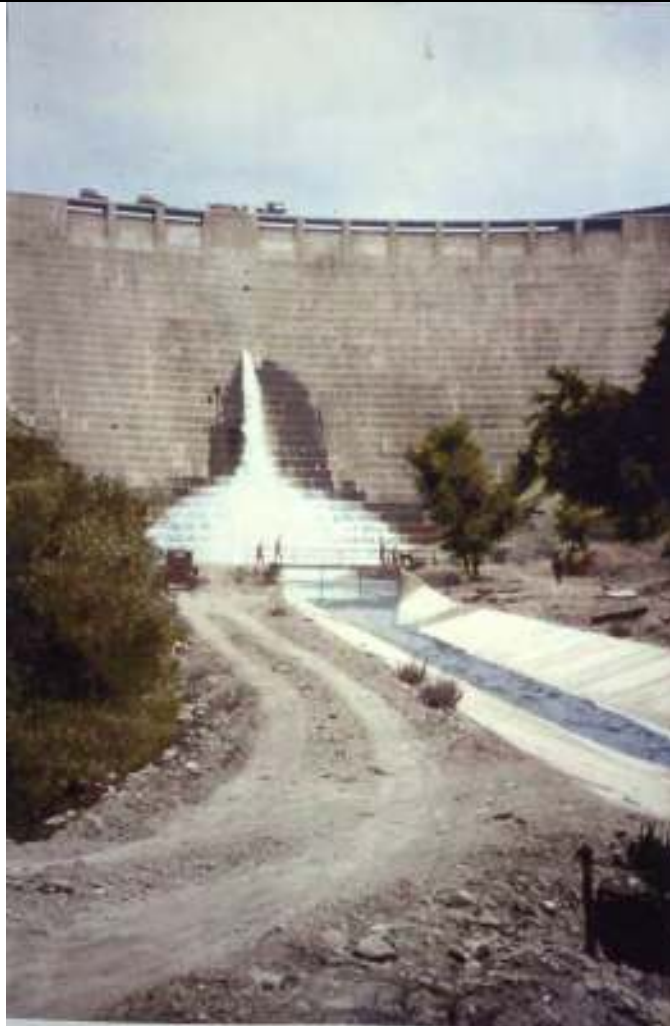
Figure 12. Frontal elevation view of St. Francis Dam, believed to be taken the day of dedication, in May 1926. Note the eleven crest spillway bays, each only 18 inches high, and the concrete-lined trapezoidal channel in foreground, which ran 7,300 feet downstream, to Powerhouse 2. Image colorized by Pony Horton.

The completed dam was opened with little fanfare in May 1926, shown in Fig. 12. The main structure incorporated eleven 20-foot wide spillway slits, only 18 inches high, and five 30-inch diameter piped outlets, seen to good effect in Fig. 12. Head gate controls for the outlet pipes and a Steven's Reservoir Stage Gage were accessed from a central control station, which can be discerned as the solid section in the fourth bay from the right abutment. These devices were situated on that portion of the dam which withstood the ensuing failure in March 1928. A concrete-lined trapezoidal channel (seen in Fig. 12) with a maximum flow capacity of 1580 cubic feet per second (cfs) was constructed between the dam and Powerhouse 2, 1.4 miles downstream, to convey outlet water from the dam to a flow gate) where discharge could be directed back into the aqueduct, or allowed to flow down San Francisquito Creek.

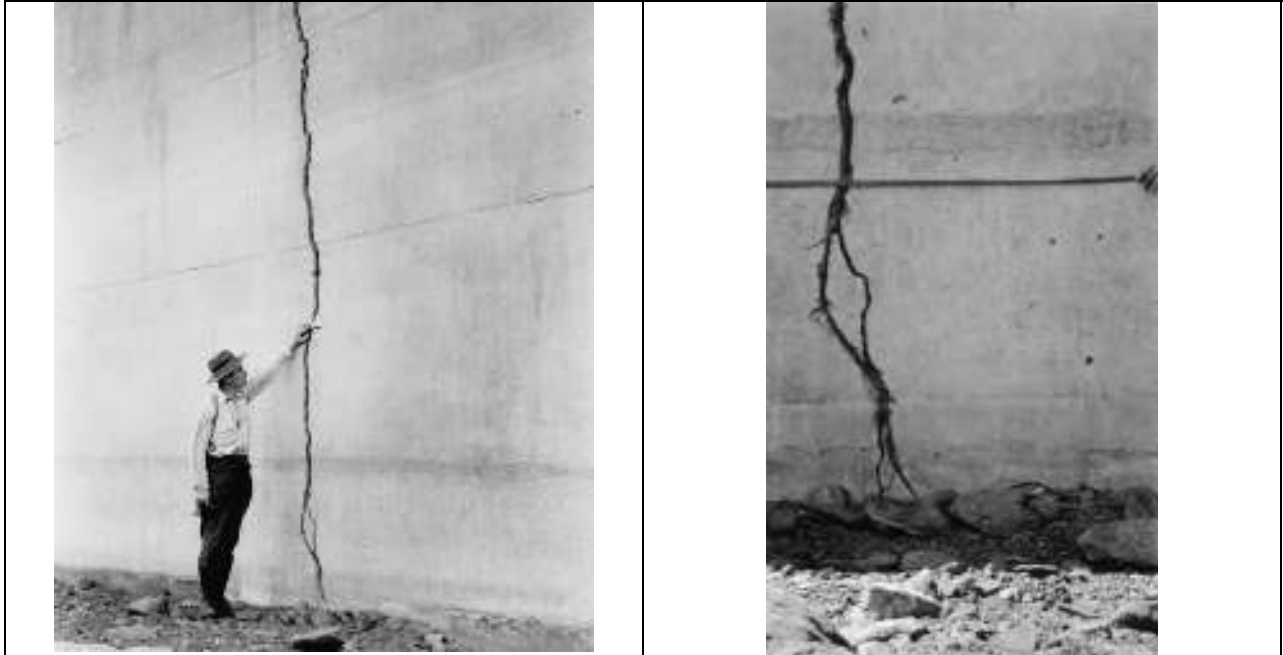
Figure 13. This was the crack discharging about 2 cubic feet per second of clear water the morning of March 12, 1928, as seen from the reservoir side, after the failure. Mulholland had come out to inspect the leak, on the opposing side of this photo, around 11 AM. Post-failure surveys indicated that the dike lifted 0.13 feet at the location, as compared to its as-built elevation. Left image from Huber Collection of U. C. Water Resources Center Archives. Right image from LaRue Collection at Huntington Library.

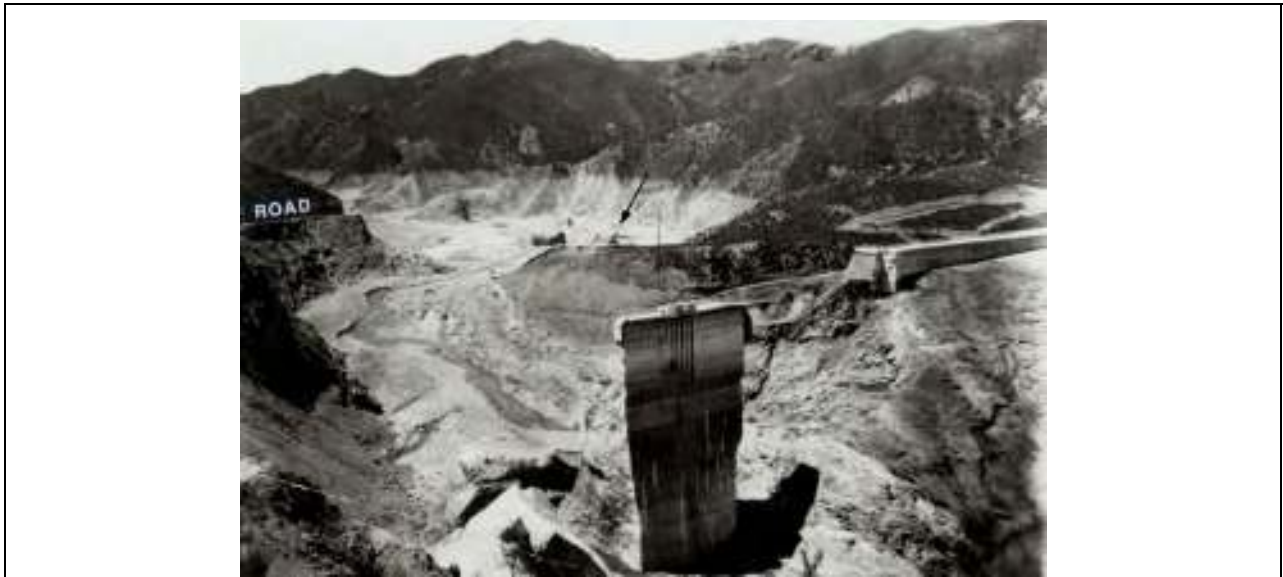
Figure 14. Downstream view of the dam site after the failure, showing location of the SCE 70 Kv Borel Power Line poles, about 60 feet above the high water mark on the right abutment, about 650 feet downstream of the dam. Photo from Ventura County Museum of History and Art.

The Southern California Edison Company's 70-Kv Borel Power Line traversed the mountain range through San Francisquito Canyon, extending eastward to Palmdale. The line was situated upon tandem sets of timber poles, and crossed the canyon about 600 feet downstream of the dam, at an elevation about 200 feet above the channel, in order to ascend the dam's left abutment (Fig.14). The line continued to rise to a position about 90 feet above the crest of the left abutment (Fig. 15). At 11:57-1/2 PM the operators at Powerhouse 1 (Silvey and Tate) noted a heavy bump, bus voltage spiking to 90, which corresponded to Southern California Edison Company's loss of power on the Borel Line. The Borel Power Lines were severed by massive landslippage of the dam's east abutment, shown in Fig.15. This suggests that the dam's catastrophic demise was ushered by a massive landslide enveloping the dam's entire left abutment, at the beginning of the failure sequence.

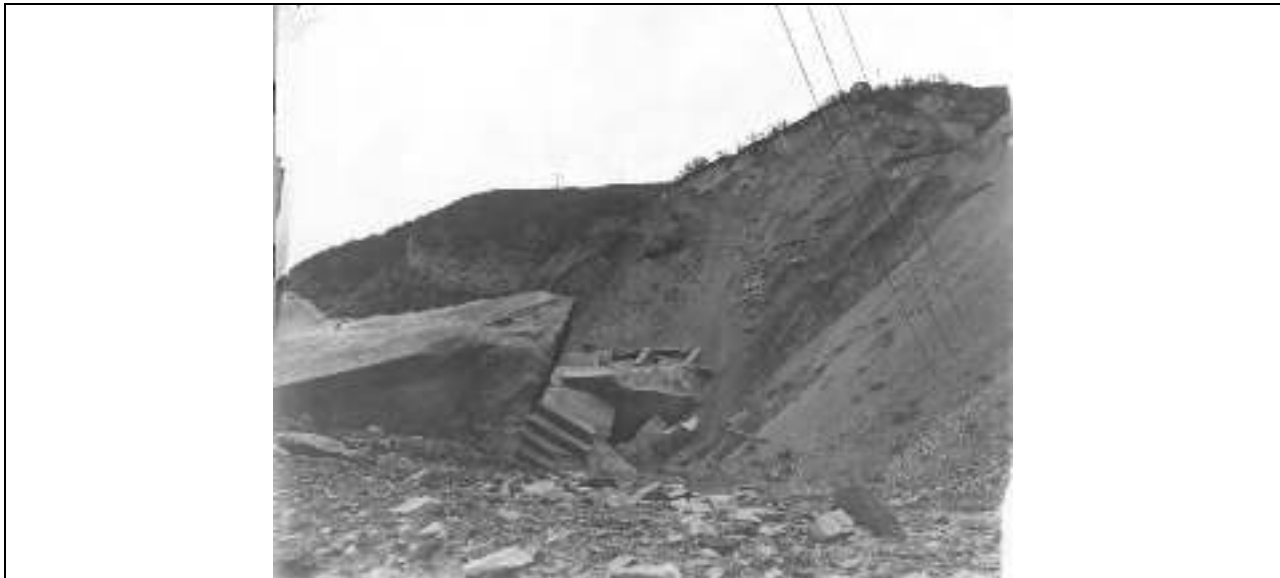
Figure 15. View looking upstream at the base of the left abutment landslide. Note the planar surface of Block 2, which broke along a cold pour joint. The three downed power lines clearly seen entering the slide area in this view had been clipped before the Governor's Board made their site inspection on March 22<sup>nd</sup>. Note tandem SCE poles in distance, upstream of the east abutment landslide. Photo by H. Wildey, author's collection.

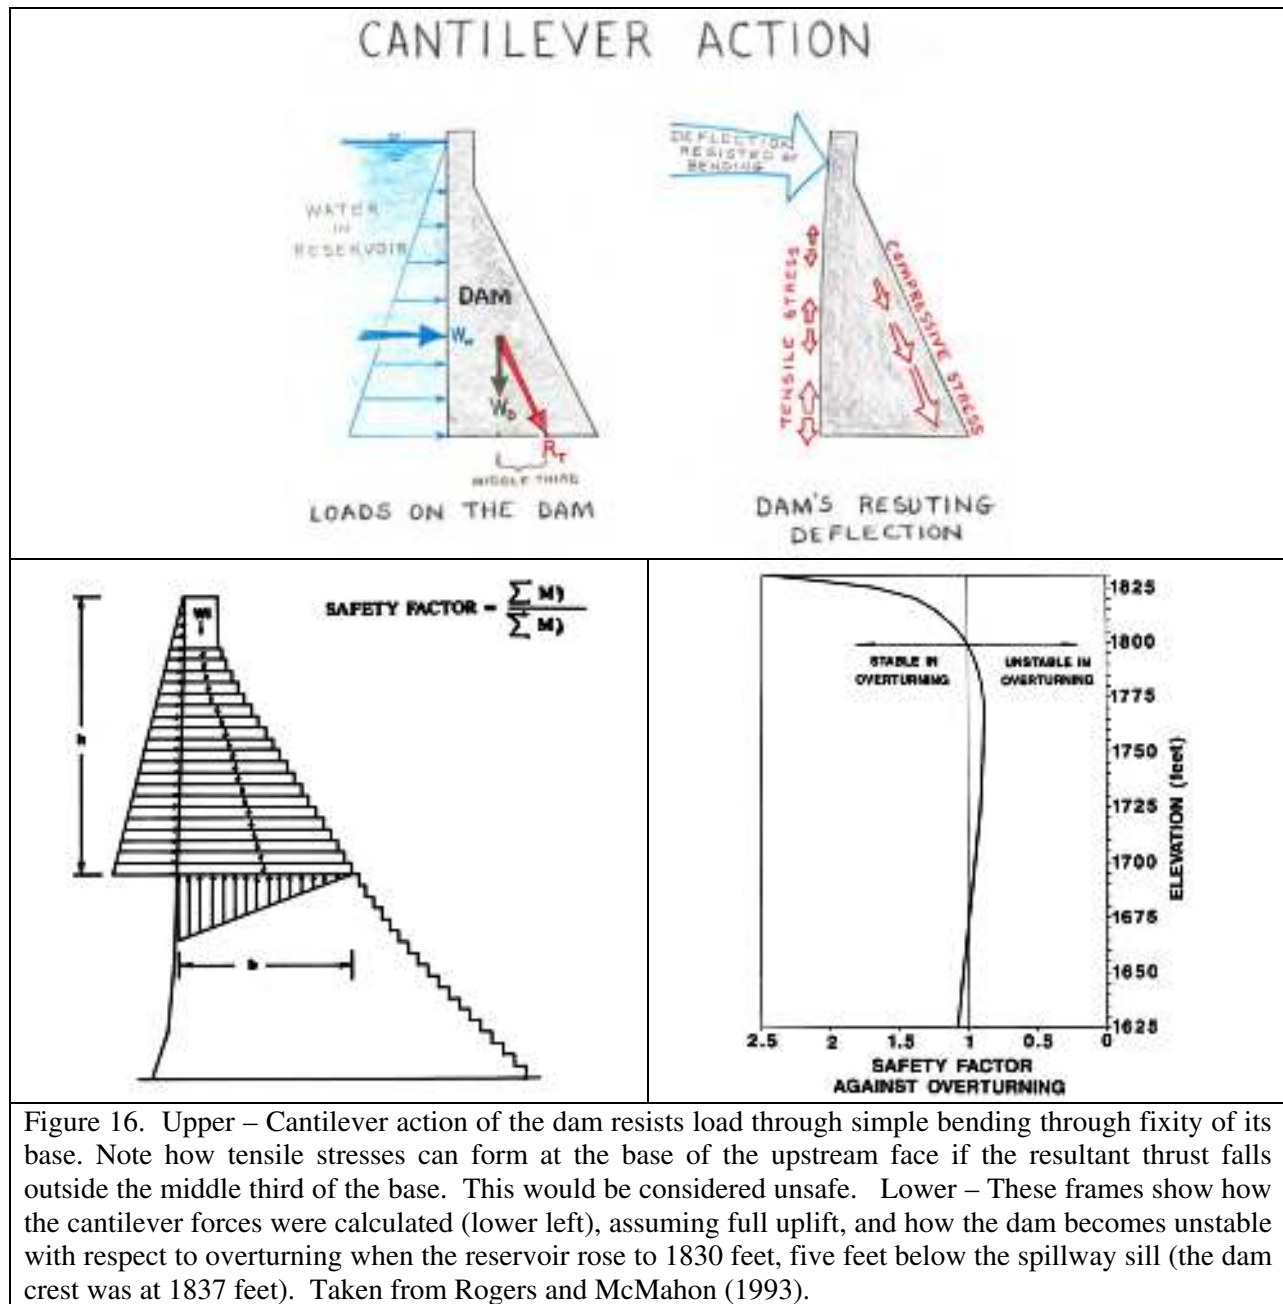
Figure 16. Upper – Cantilever action of the dam resists load through simple bending through fixity of its base. Note how tensile stresses can form at the base of the upstream face if the resultant thrust falls outside the middle third of the base. This would be considered unsafe. Lower – These frames show how the cantilever forces were calculated (lower left), assuming full uplift, and how the dam becomes unstable with respect to overturning when the reservoir rose to 1830 feet, five feet below the spillway sill (the dam crest was at 1837 feet). Taken from Rogers and McMahon (1993).

As shown in Fig. 16-upper, a mass concrete gravity dam cannot theoretically sustain tension in its heel, or it becomes unstable in overturning. The resultant thrust ( $R_T$ ) is the vector sum of the dam's dead weight (pushing downward) and the pressure of the reservoir water (pushing horizontally, against the dam). The inclination of the resultant thrust must remain within the middle third of the dam's base to prevent the heel from separating from the underlying foundation. For this reason, masonry dams over 200 feet high are generally battered on their upstream face, to widen their footprints and, thereby, keep their upstream heels out-of-tension.

-lower right shows the results of these summations. These back-analyses revealed that the structure becomes unstable in overturning when the reservoir pool was raised to within five feet of the spillway lip (elevation 1830 feet), a condition that occurred five days previous to the failure (Rogers and McMahon, 1993). The reservoir pool had been brought up to within 3 feet of spillway sill the previous year for just one day (May 10<sup>th</sup>), then maintained at 4 feet below crest for another two weeks, until May 25<sup>th</sup>, when it was drawn down to 1812 to 1820 ft through the balance of the year. The reservoir pool was then brought through elevation 1830 on February 5<sup>th</sup>, and maintained above this level for the next 36-1/2 days, until the failure. This would have allowed time for increased percolation beneath and around the dam, into its abutments.

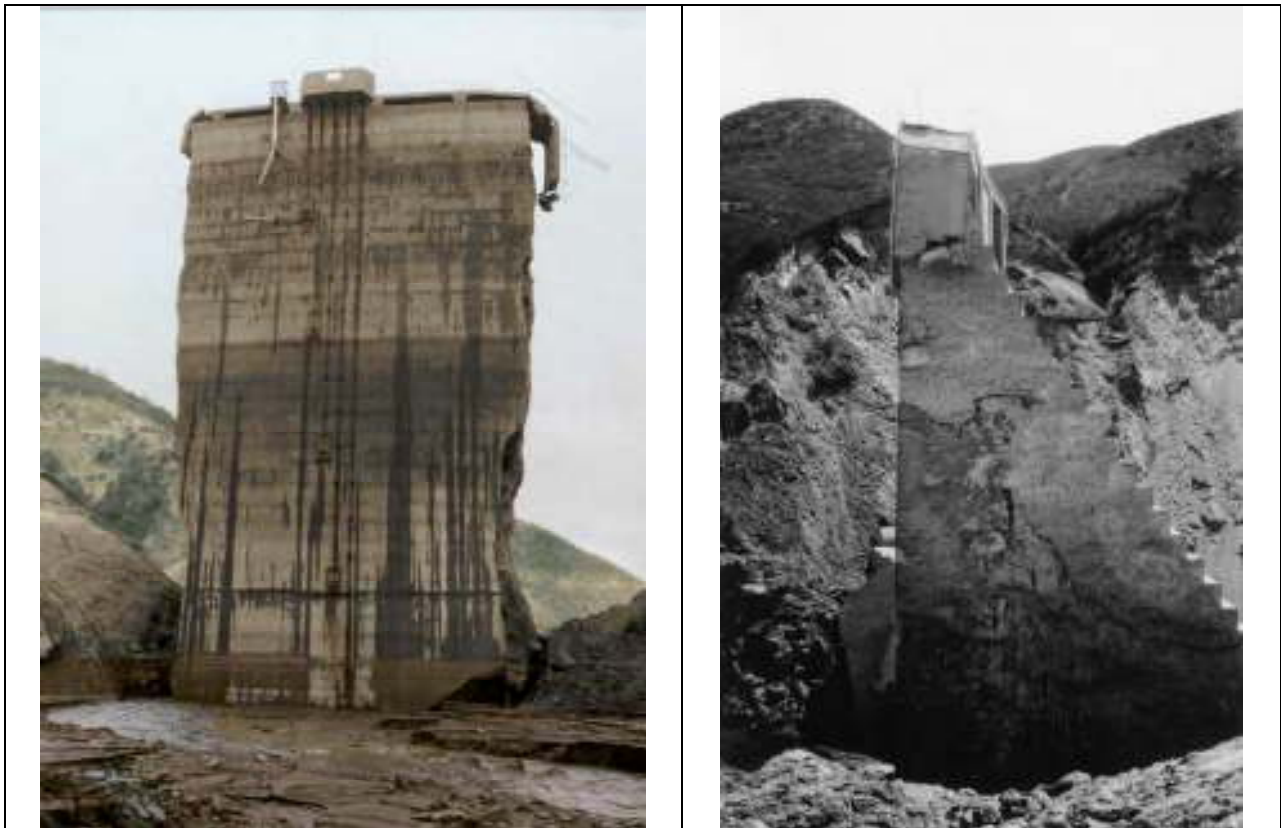
Figure 17. Left - Carl Grunsky discovered the gage attendant's wooden ladder wedged inside an enormous tension crack in the right upstream heel of Block 1 (from Ventura County Museum of History & Art; colorized by Pony Horton). Right – Profile view of the Block 1 monolith. No discernable upstream batter can be seen near elevation 1730, about half the height of the block (from La Rue Collection of the Huntington Library ).

One of the most interesting aspects of the post-mortem analyses of St. Francis Dam concerns the massive tension crack exposed in the upstream heel of Block 1, discovered by San Francisco engineer C. E. Grunsky (see sidebar discussion) about two weeks after the failure, when the ground around the upstream face of Block 1 had drained sufficiently to see more details. The wooden ladder (Fig. 18) came from a position about 50 feet southeast and 100 feet below where it was affixed to the dam's upstream face, between the Stevens Stage Gage stilling pipe and the pull-rod for Outlet Sluice Gate No. 2 (see left side of Fig. 17 left, below).

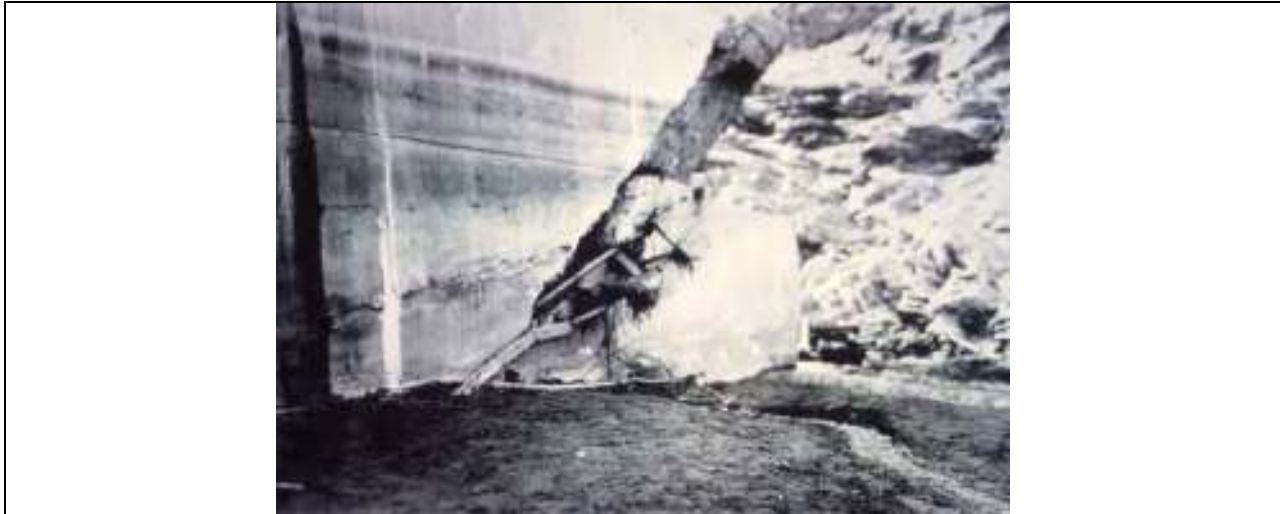
Figure 18. Detail view of the wooden gage attendant's ladder found in a large tension crack in the right upstream heel of Block 1. This testifies to significant deformation of Block 1, tilting downstream under active hydrostatic pressure. Some of this may have occurred after Block 2/3/4 fell away, removing lateral restraint on the left side of Block 1. Photo taken from Outland (1963).

The existence of such a large tension crack in this portion of the dam was mute testimony of a seriously overstressed structure. Subsequent structural analysis by the author revealed that the presence of a crack in the heel of Block 1 would have shifted the dam's resultant thrust some 240 feet downstream of the dam, when it would need to be within the middle third of the dam's base to maintain stability (Figs. 16 and 20). No dam could withstand such imbalance, as the reservoir's full hydrostatic pressure would have entered such a fracture and greatly reduce the effective weight of the dam's concrete. These findings suggest that the progressive drop in reservoir level recorded by the Stevens Stage Gage during the hours preceding the failure appear to correspond with tilting of the dam's central core, due to its being overstressed (Fig. 20). So, it
