# **The 1928 St. Francis Dam Failure and Its Impact on American Civil Engineering**

*J. David Rogers*

## **THE 1928 ST. FRANCIS DAM DISASTER**

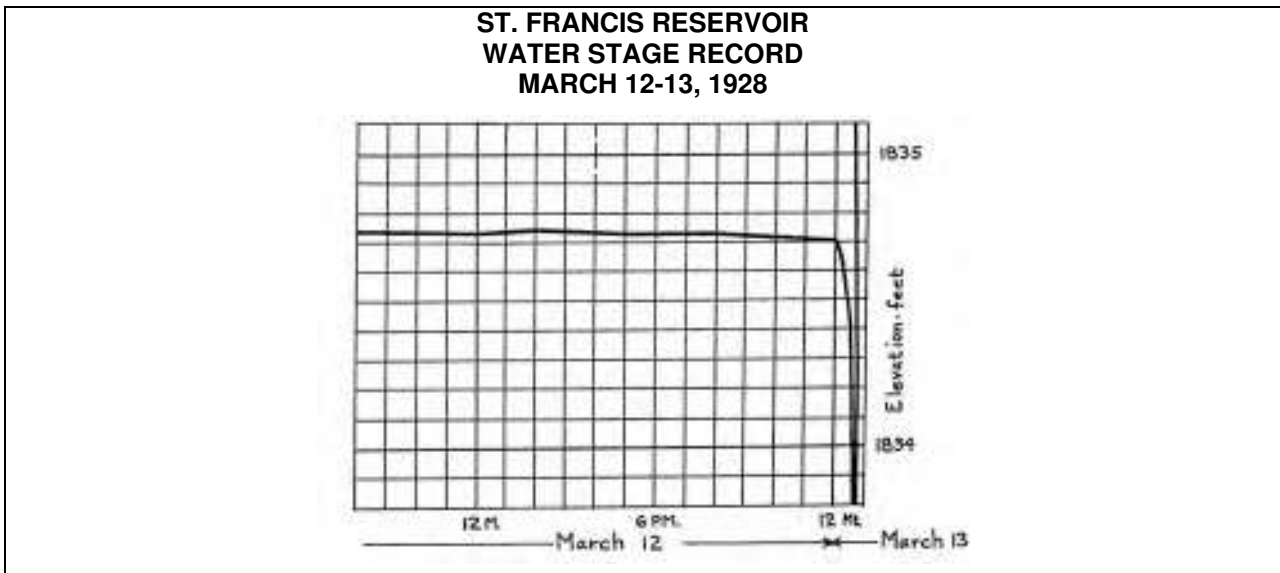
Figure 19. Charles Lee's reconstruction of the Steven's Gage record recovered from the crest of Block 1 after the failure. Note the increasing drop in reservoir stage that began about 40 minutes prior to the 11:57-1/2 PM failure. Lee (1928) recognized that this deformation might have come from the left abutment pushing against the dam and "lifting it slightly." The gage appears to have recorded cantilever deformation of the main dam, deflecting almost two degrees from vertical when the dam collapsed.

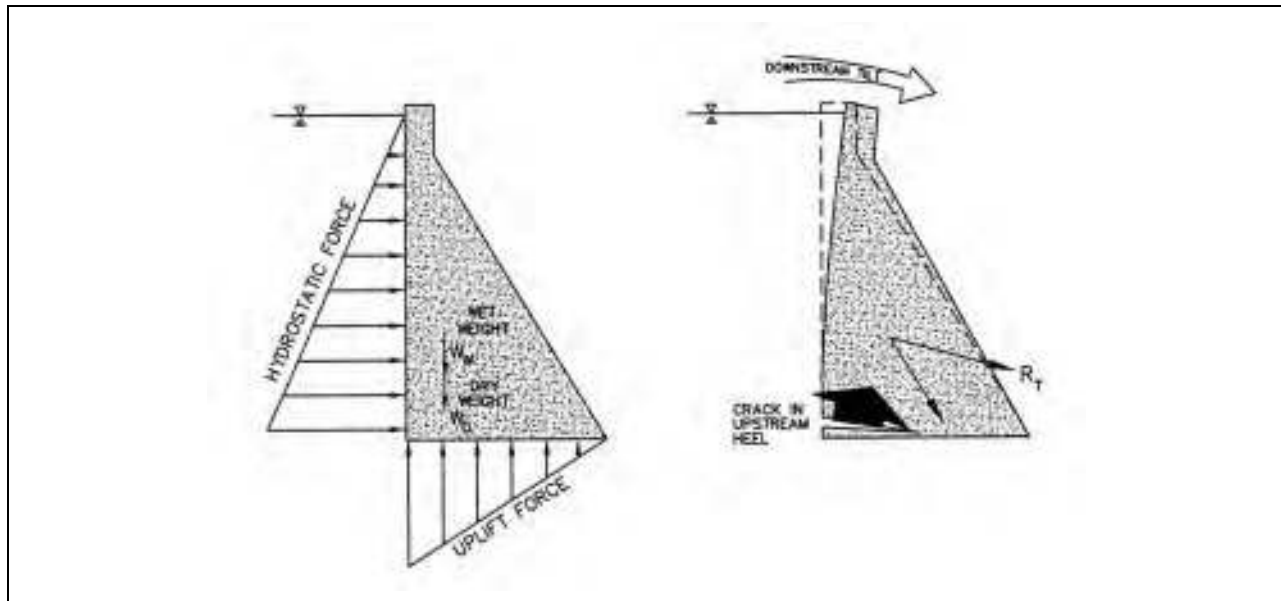
Figure 20. Left - The resultant thrust within a gravity dam is the vector sum of the horizontally-inclined hydrostatic force and the vertically-inclined dead weight of the dam. Stability in overturning requires that the resultant thrust  $R_T$  be within the middle third of the dam's base. BWWS engineers ignored uplift forces in their analyses because they installed 10 uplift relief wells under this portion of the dam, which did not fail. Right - The Steven's Gage attached to Block 1 faithfully recorded a drop of 12 inches in 40 minutes, which would equate to a 2 degree tilt about an axis of rotation at the deepest point of Block 1, about 106 feet downstream of the dam's upstream heel.

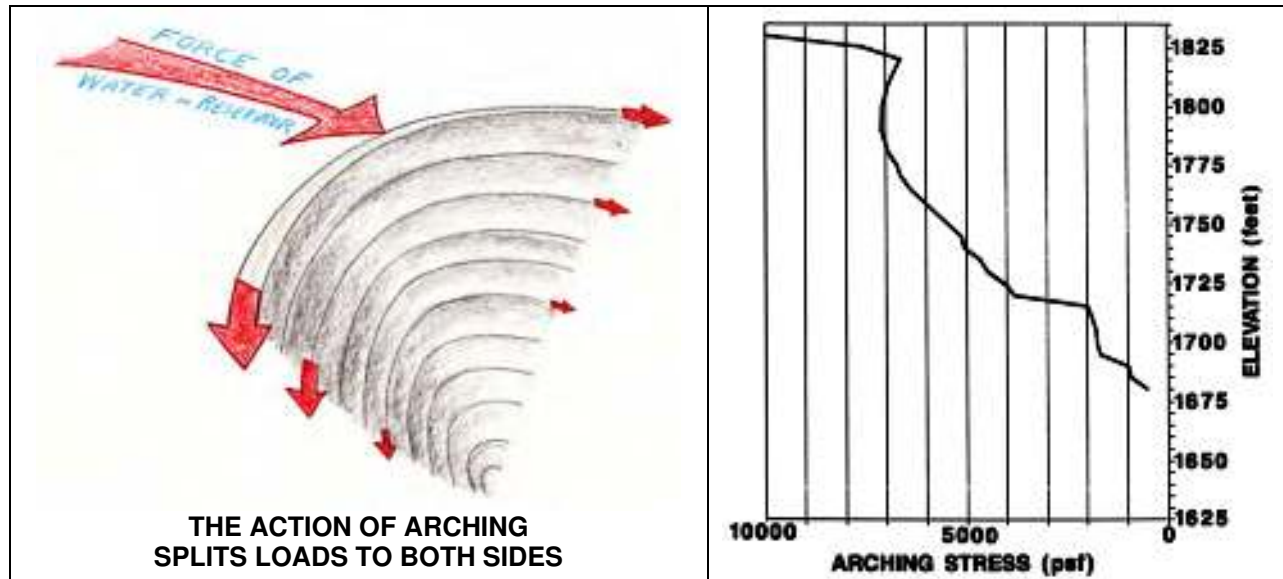
Figure 21. Left – Arching transfers loads horizontally as thrust onto both abutments of a curved dam. These loads typically increase upward in the dam, because the structure has diminishing cross sectional area upwards toward the crest (a given load divided by a smaller and smaller bearing area at the abutments, yields progressively greater force per unit area). The tighter the arch radius, the greater the percentage of the imposed load that can be transferred to the abutments. Right – Plot of arch stress versus elevation from Rogers and McMahon (1993). This suggests that the arching stress began to elevate significantly when the reservoir rose to within 10 feet of spillway sill, around elevation 1823 ft.

Arch stresses typically increase upward in a constant radius arch dam, because of diminishing dam mass (Fig. 21-left). Rogers and McMahon (1993) performed modern structural assessment of arch loads on the main section of the St. Francis Dam. The results were as perplexing as those accomplished on cantilever stresses (Fig. 21-right). Arching stresses towards either abutment exceeded 10,000 pounds per square foot (5 tsf) when the reservoir pool was raised to within three feet of the spillway. The decision to raise the dam 20 feet without

widening the dam's base was one of the more significant design flaws that can easily be appreciated today.

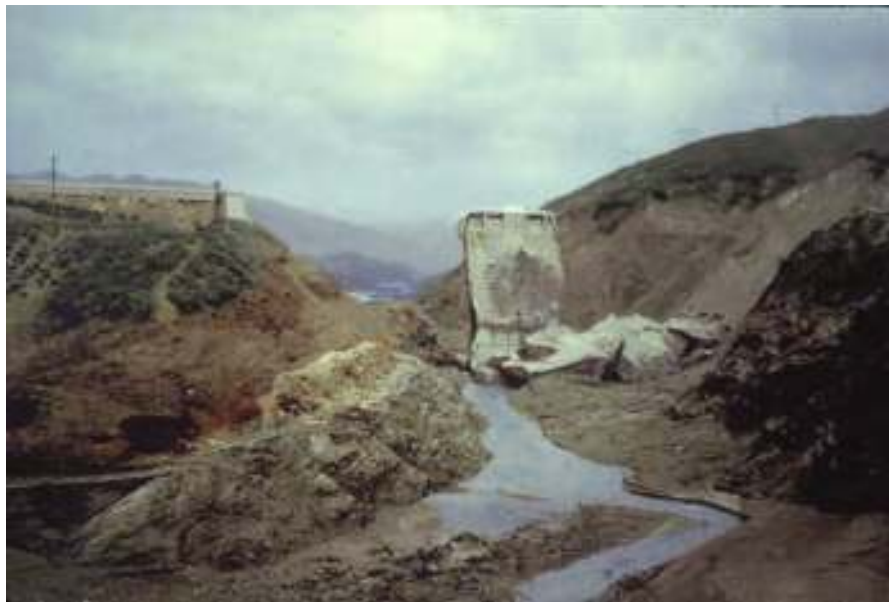
Figure 22. Upstream view of the dam site, taken within five days of the failure, when the downed power lines were still visible, leading into the left abutment landslide. Note position of the intact power poles high above the reservoir water line in background. Photo from C.H. Lee Collection, U.C. Water Resources Center Archives, colorized by Pony Horton.

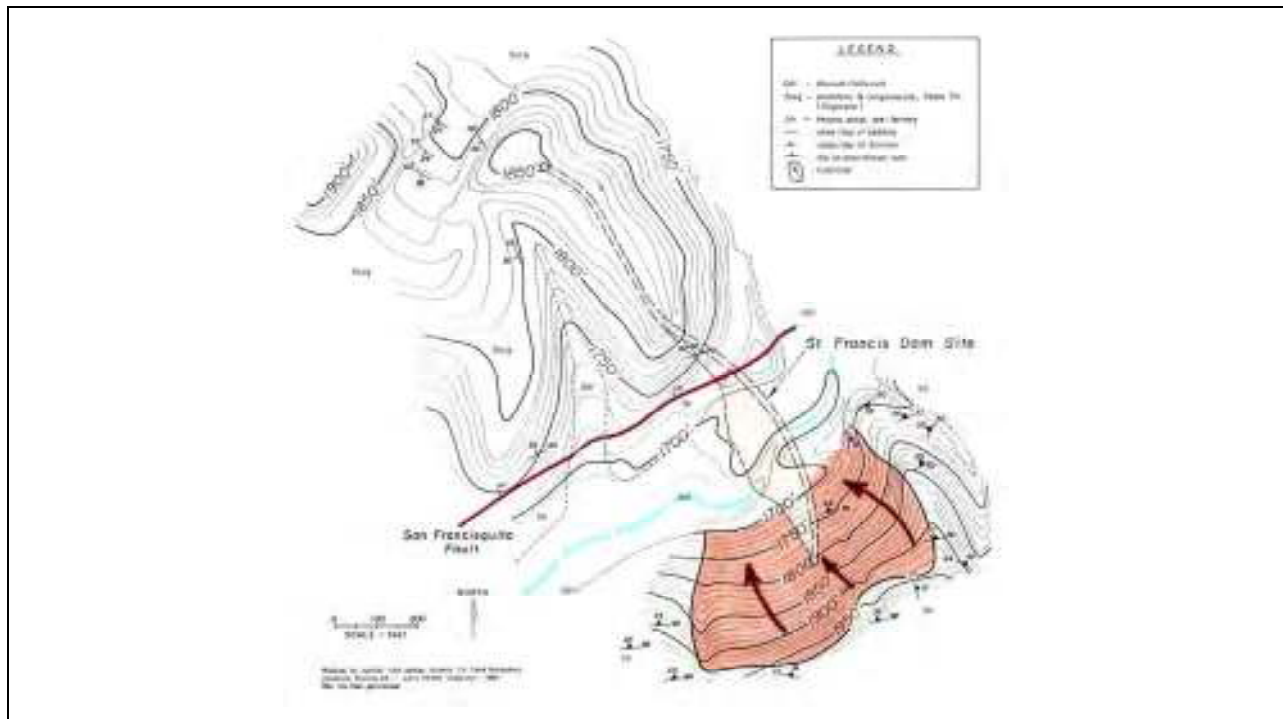
Figure 23. Plane table topographic map of the existing dam site made by students at Cal Poly Pomona in 1980. The original position of the dam is shown in its former position, using survey data provided by LADWP. Note position of the dam crest with respect to the left abutment landslide, right in its center.

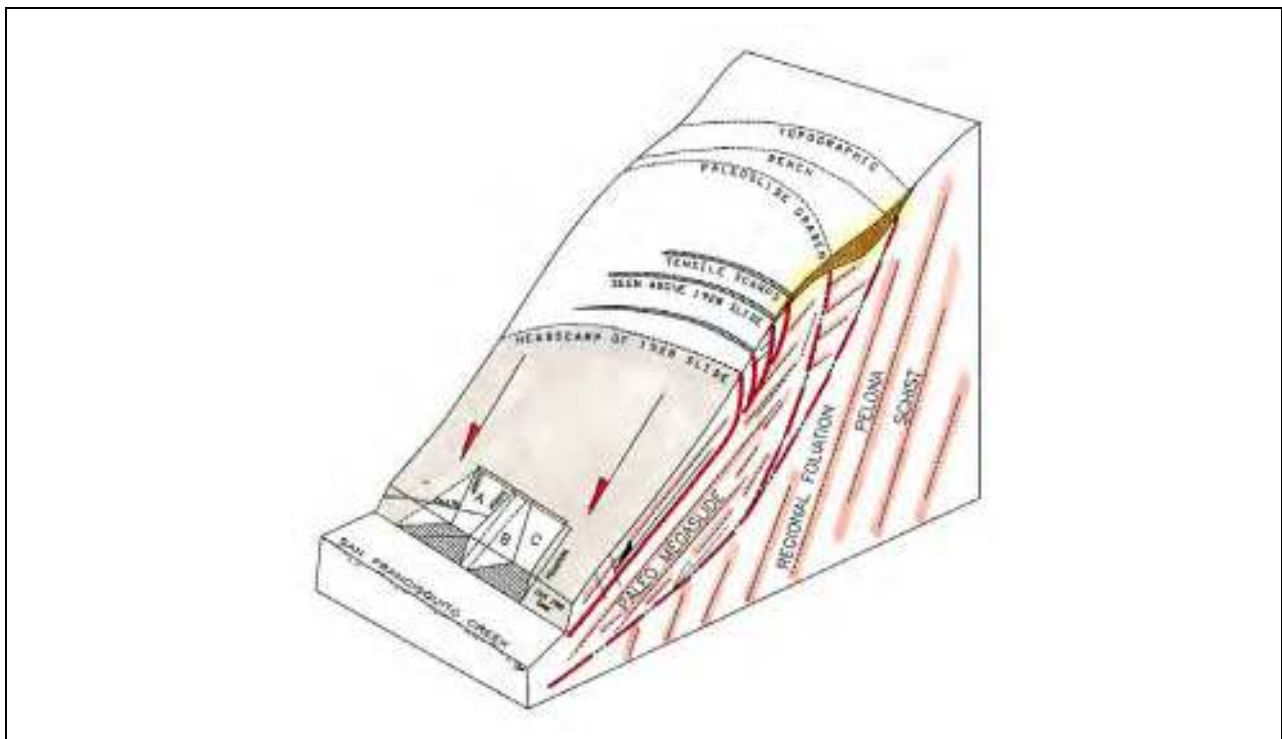
Figure 24. Schematic block diagram of the base of the dam's east abutment, showing rock wedges A, B and C in the Pelona schist predicted by the keyblock analysis. A 60° cut at the base of the left abutment created an unstable situation with respect to this family of keyblocks, based upon measurement of discontinuity suites recently measured in the left abutment scar.

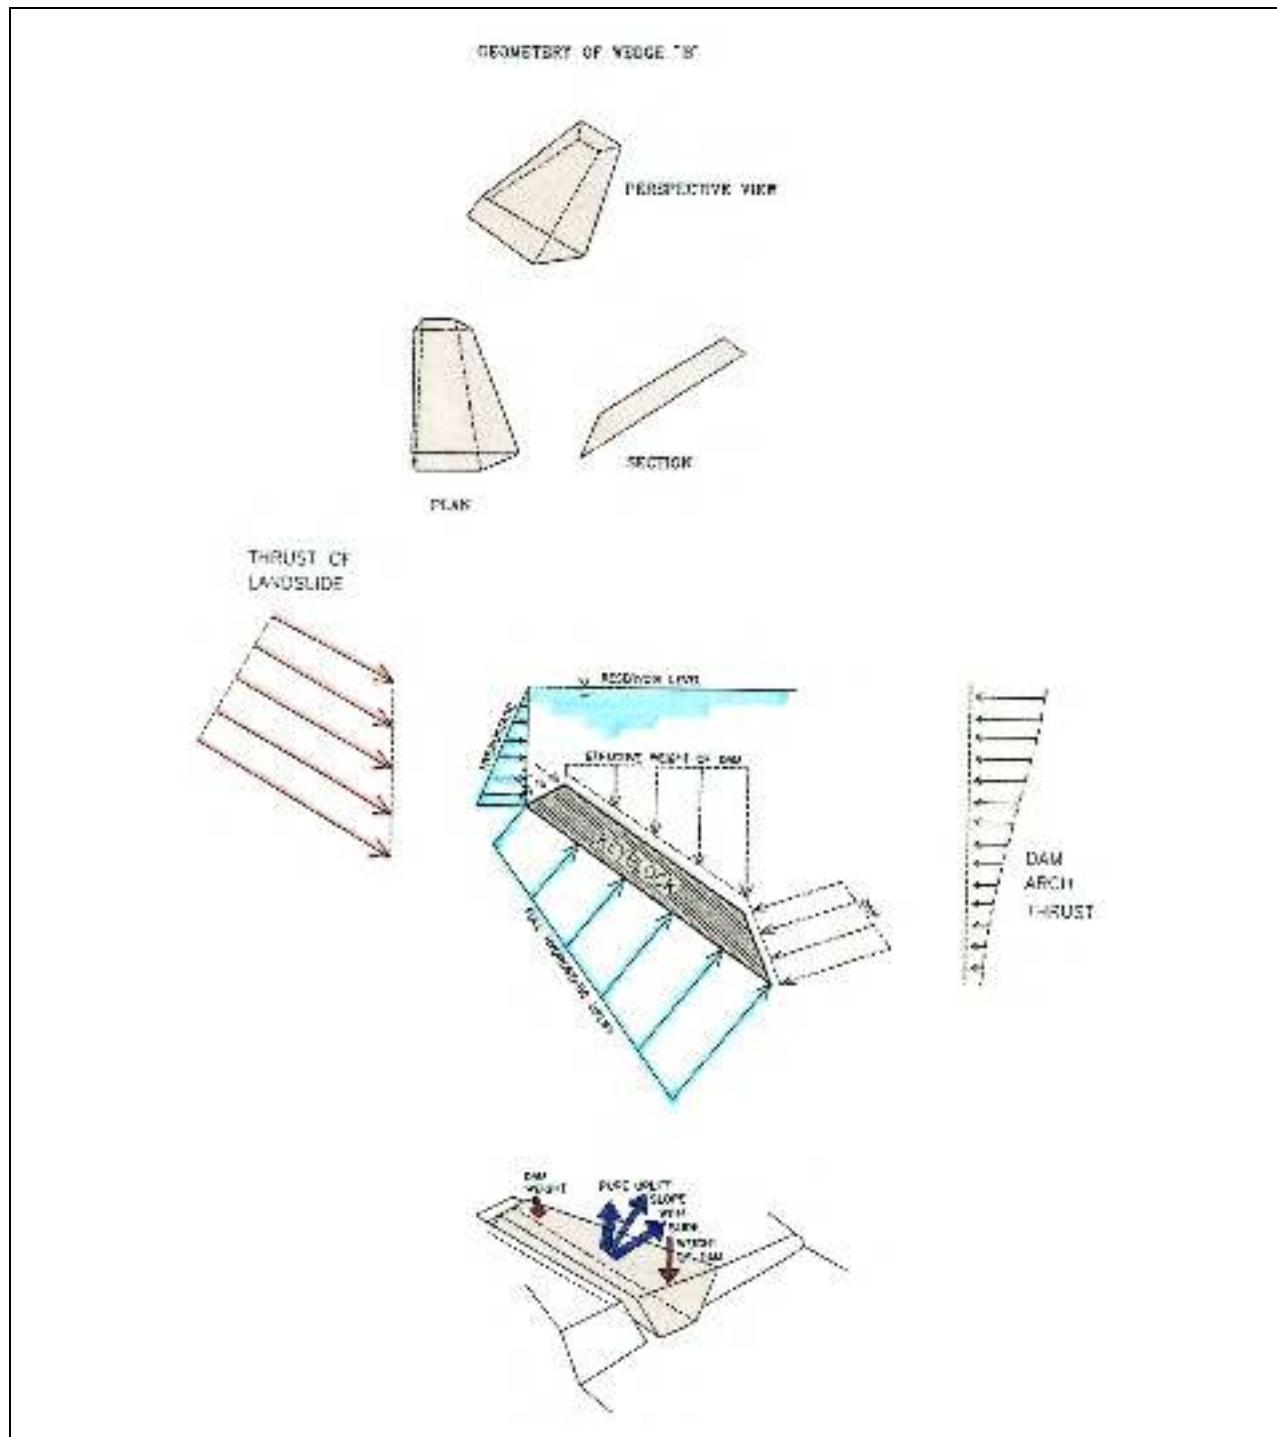
Figure 25. Plan, elevation and perspective views of keyblock B, shown in the previous figure. The elevation view (middle) parallels the foliation of the schist, normal to the dam's abutment. The forces acting upon this block are sketched in. Full hydrostatic uplift would be acting upon the block because the sloping abutments were without any manner of seepage cutoff, grout curtain, or uplift relief wells. The lower figure shows the predicted uplift of keyblock B, in vicinity of Block 35 (Fig. 40).

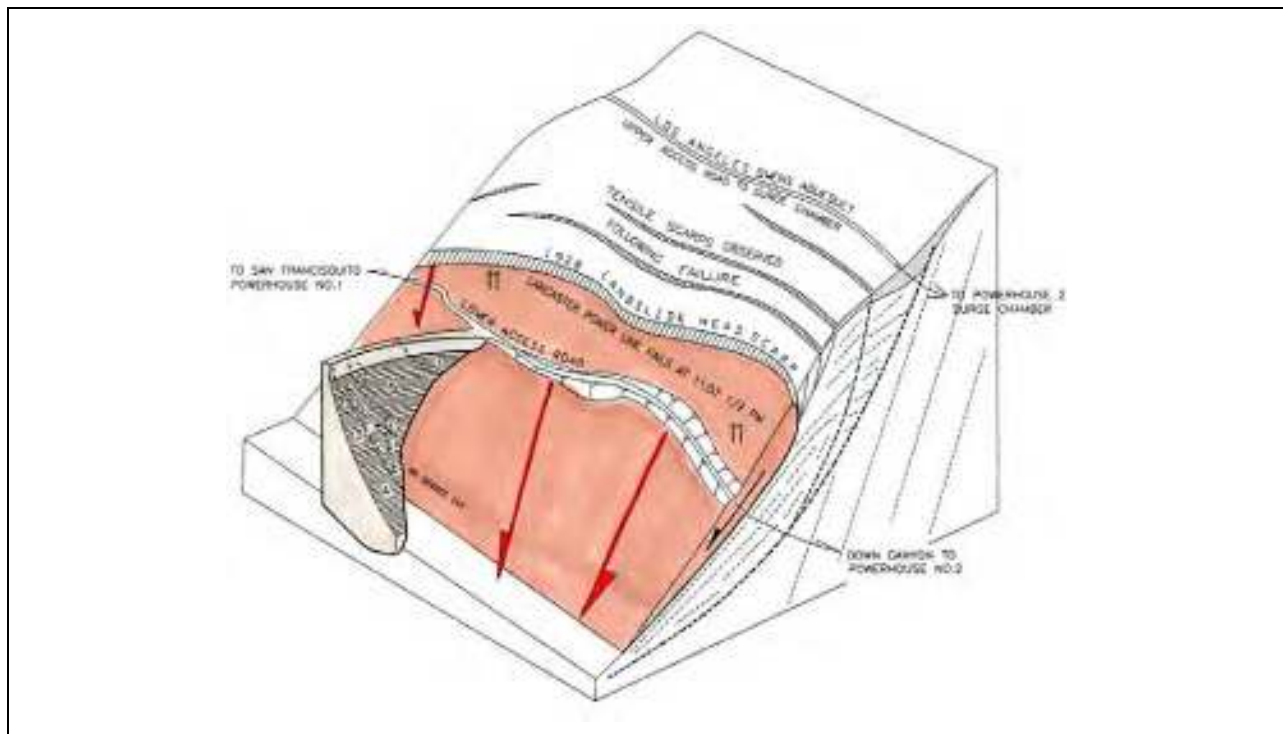
Figure 26. Schematic block diagram of the left abutment area, showing the approximate areal limits of the 1928 east abutment landslide. Bailey Willis (1928) was the only person who recognized that the east abutment slide was only a small portion of a much larger prehistoric landslide developed within the schist.

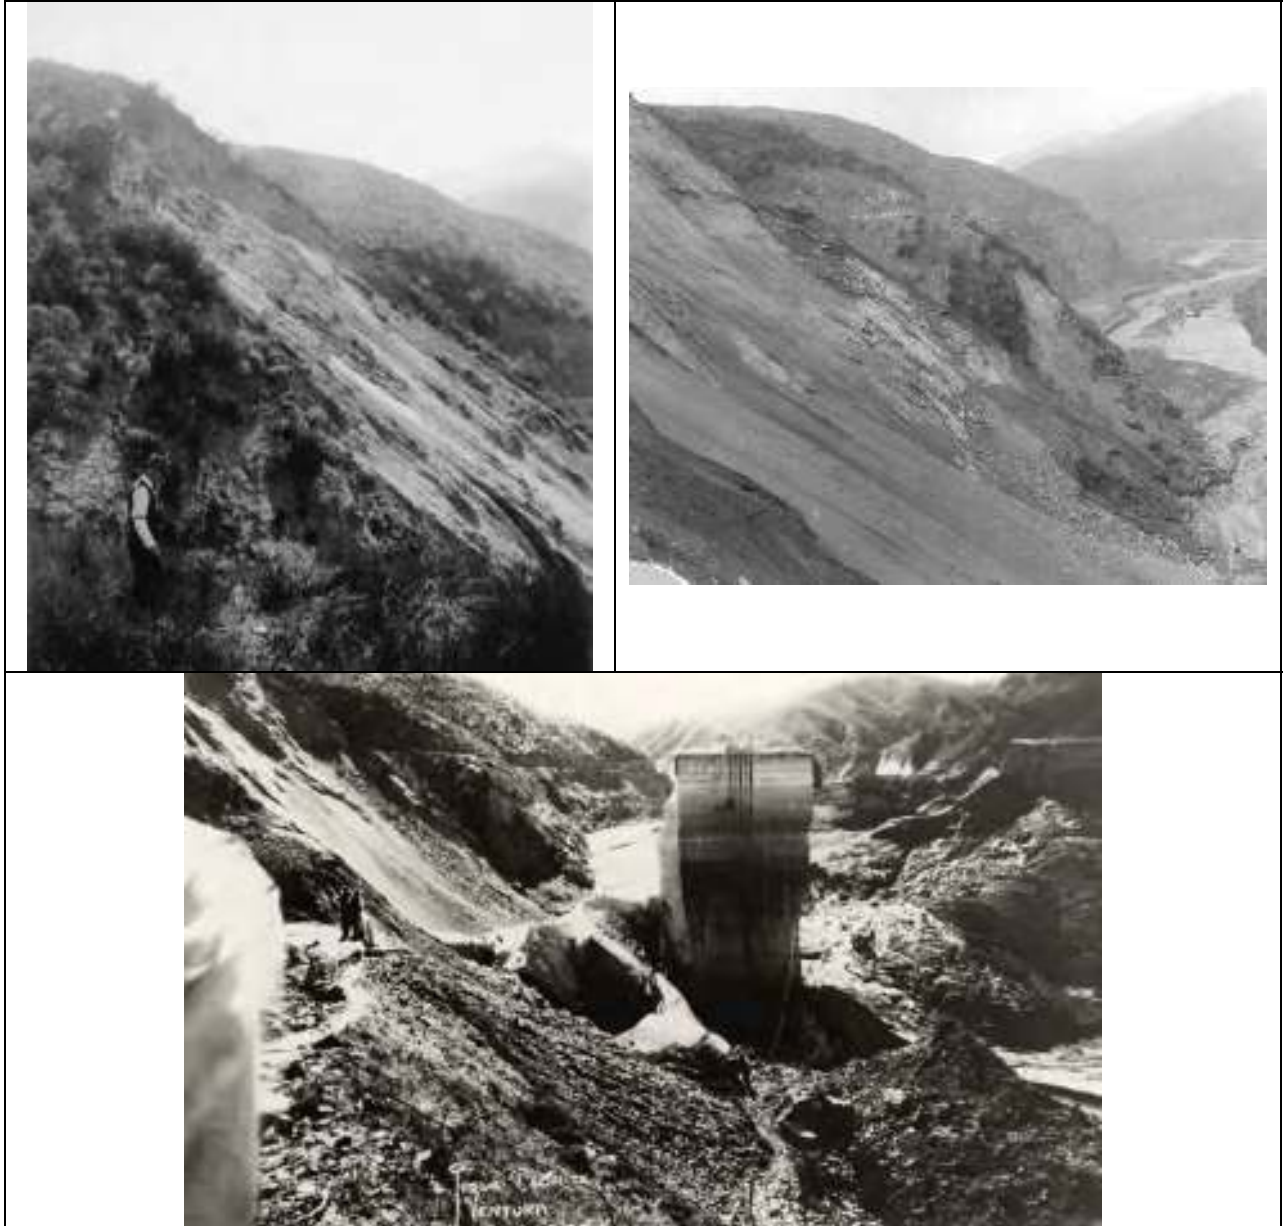
Figure 27. Upper - Downstream views of the planar foliation surface exposed in the east abutment landslide. Note the near vertical headscarp, about 40 feet high (from Grunsky report in St. Francis Dam Disaster Collection at the Huntington Library). Lower – A similar view, but taken from behind the dam. The left abutment slide carried the dam’s sloping abutment section across the downstream face of the main structure, from left to right (Ventura County Museum of History and Art).

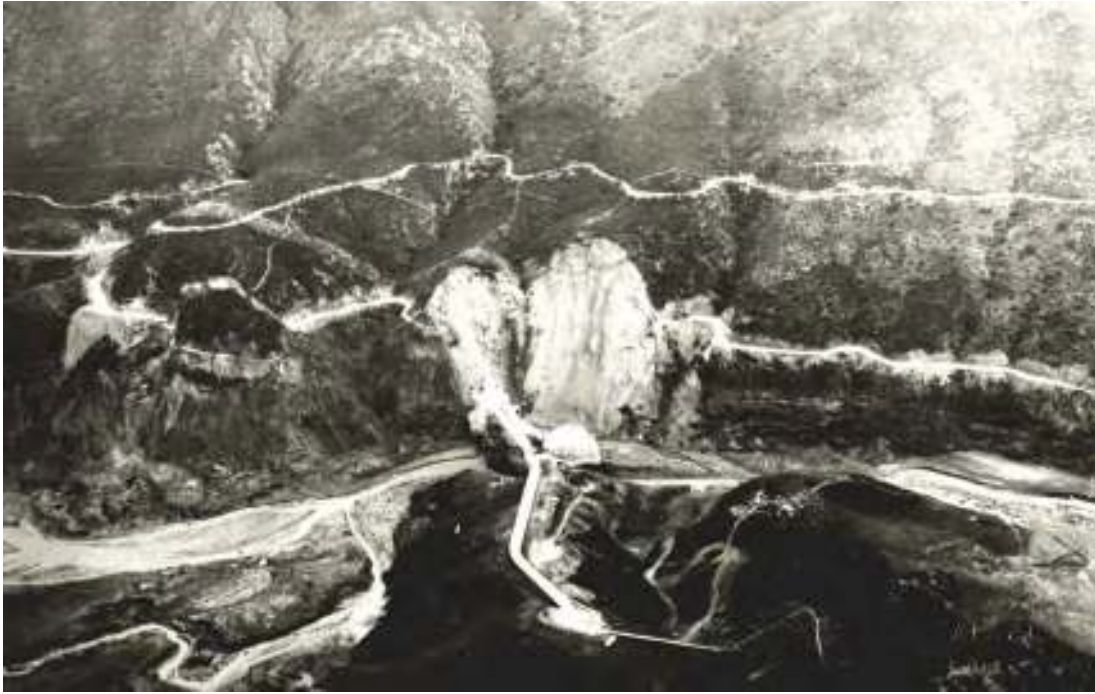
Figure 28. Aerial oblique view of the dam site by Spence Aerial Surveys the morning after the failure. Note the position of the east abutment landslide and old San Francisquito Canyon Road with respect to the dam (from the UCLA Spence Photo Collection).

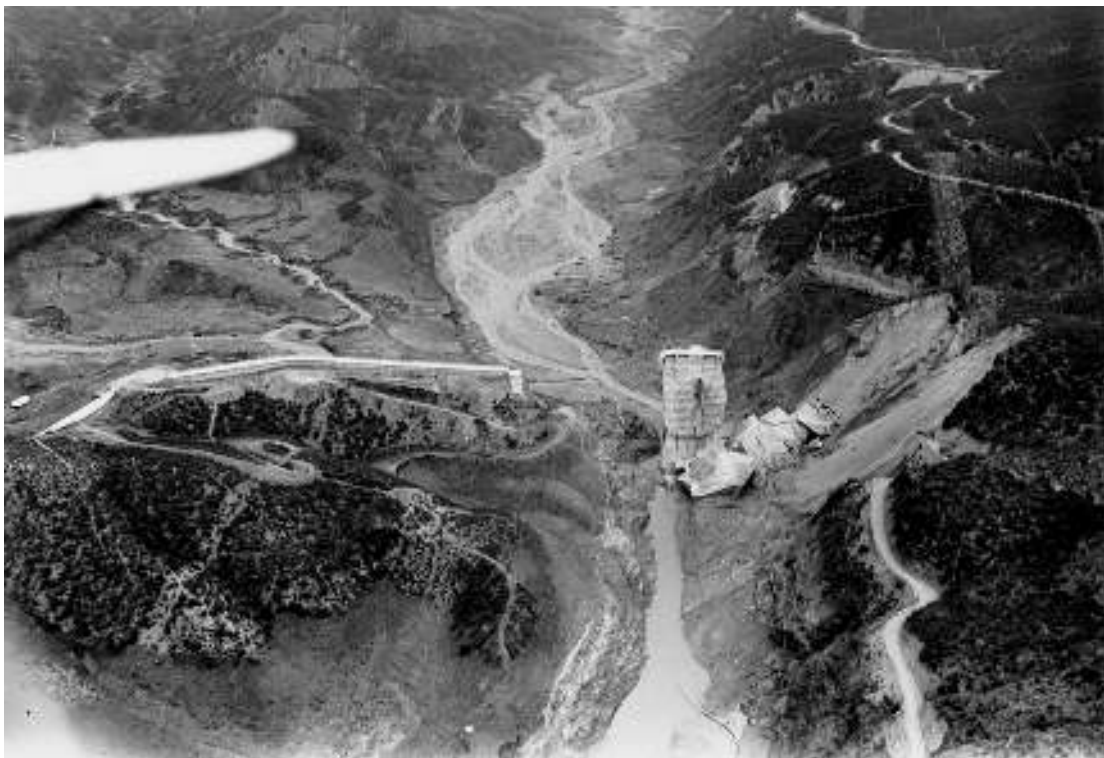
Figure 29. Aerial oblique view looking upstream at the dam area the morning after the failure. Note how high the east abutment landslide extended above the reservoir. Also, note the massive slump block upstream of the dam, caused by rapid drawdown (UCLA Spence Photo Collection).

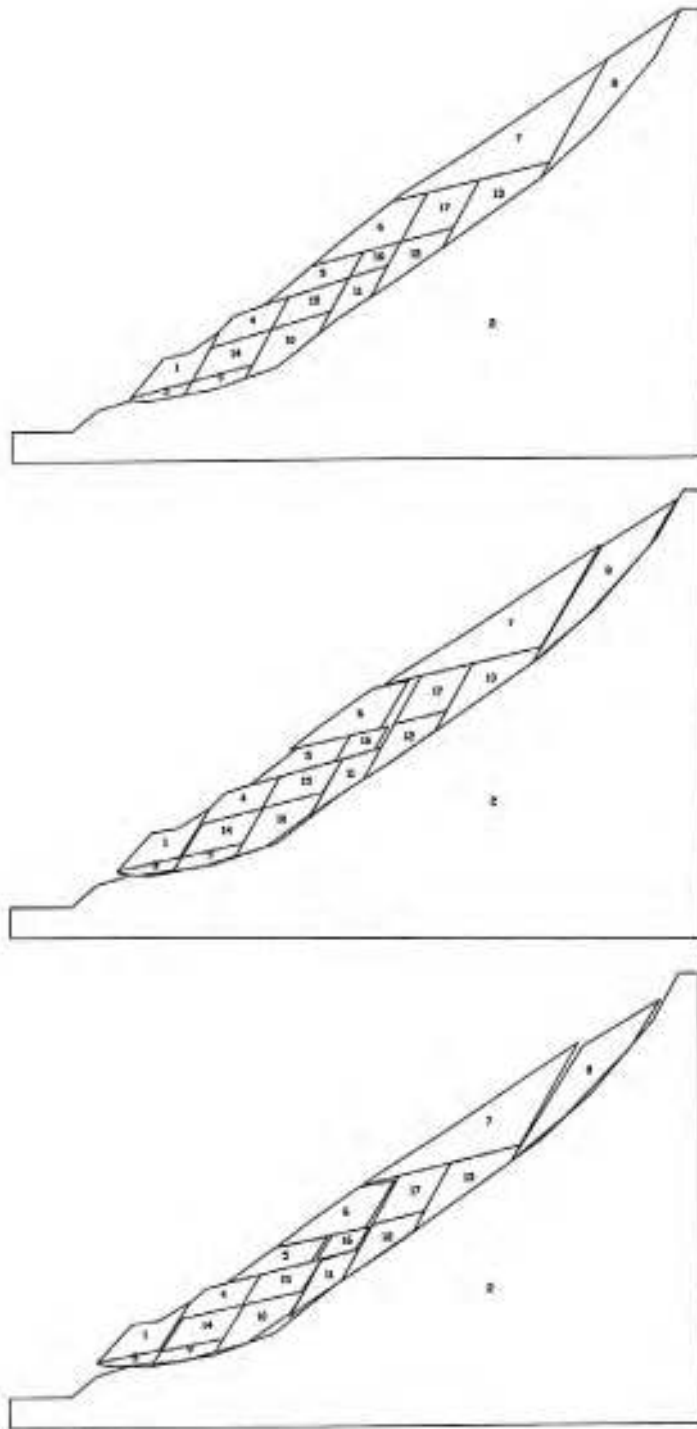
Figure 30. Discontinuous Deformation Analysis of the east abutment landslide, performed by Max Ma. These sections show the destabilizing effects of lateral loss of restraint that triggered upslope migration of the slide mass. Pore pressure entrapment likely developed at the base of the slide, beneath wedges 3, 9, 10 and 11, reducing the friction along the planes of schistosity.

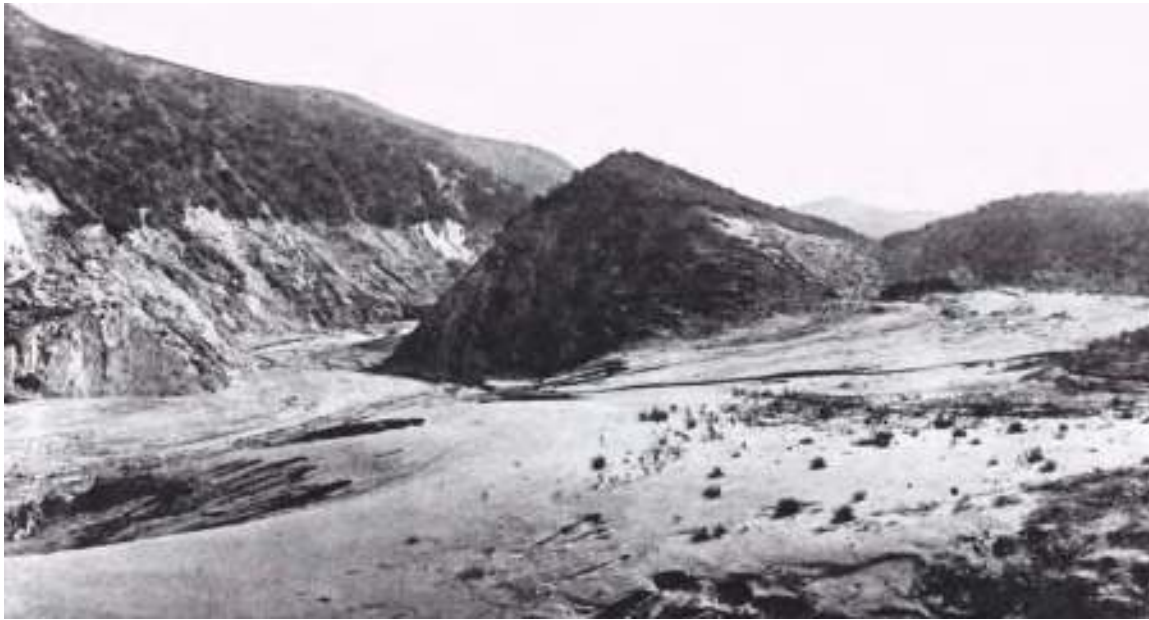
Figure 31. Downstream view of the silt blanket deposited by the flood, just above the first hairpin turn of San Francisquito Creek, about 1,000 feet upstream of Powerhouse 2 (taken from the 'C' in Canyon on Fig. 36). The flood detritus is predominately Pelona Schist, and the grain size distribution is quite uniform. At the peak of the outbreak flood, water spilled over the saddle at middle right (from the Huber Collection, U.C. Water Resources Archives).

Fortunately, many photographs were taken of the canyon bottom, between the dam site and the remains of Powerhouse 2, about 7,300 feet downstream. Fig. 31 shows a downstream view of the silt banks deposited by the flood about 4,500 feet downstream of the dam. A number of cross sections were surveyed in the canyon, and presented in the Report of the Governor's Commission to Investigate the Failure (California, 1928). The silt seen in Fig. 31 can still be accessed, and comparative photos were taken at these same locations, then offset photos, in order to develop stereopairs, from which terrestrial photogrammetry methods could be employed to survey the elevations of the outbreak flood high water lines along the canyon walls. As one progresses upstream, the flood detritus, almost wholly comprised of Pelona Schist from the left abutment landslide, becomes increasingly coarse. This can be appreciated in Fig. 32, which shows Blocks 44, 27 and 43 sitting atop schist detritus of average 12-inch size. Sieve analyses of the flood detritus show it to be well sorted (all the same relative grain size) within any given stratum. As the flood flow diminished, progressively smaller size detritus was deposited upon the more coarse fractions. This stratigraphic sequence is typical of short-lived outbreak floods with diminishing flow volumes.

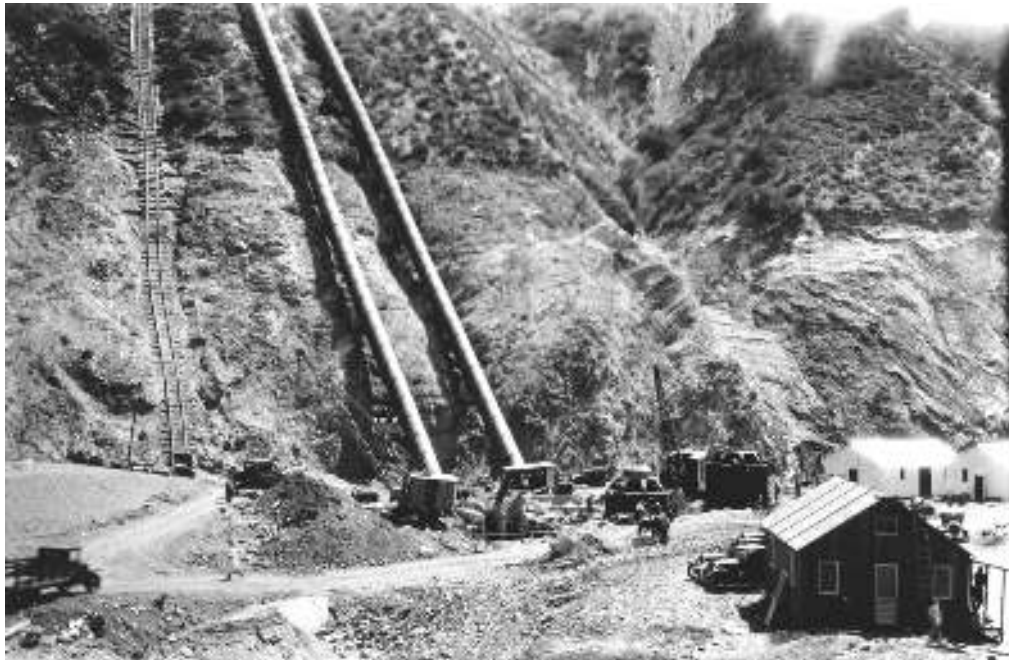
Figure 33. Rebuilding activities at Powerhouse 2 a few weeks after the failure. Surge chamber attendant E. H. Thomas descended the slope along the tramway tracks at left, reaching the high water mark at 12:15 AM, and noting that the flood waters had already dropped 20 feet. The maximum depth of flow here was about 110 feet above the channel (Huber Collection, U.C. Water Resources Center Archives).

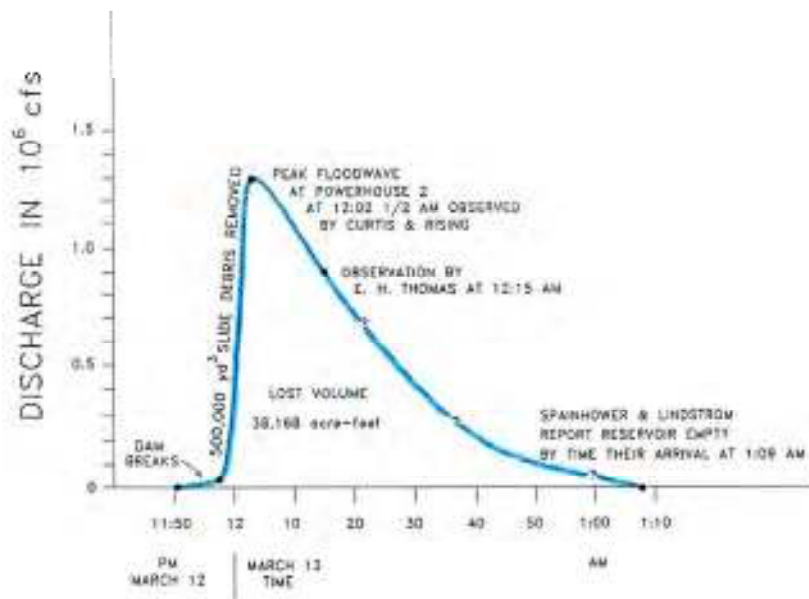
Figure 34. Reconstructed hydrograph for the outbreak flood at Powerhouse 2, approximately 7,300 feet downstream of the dam. Observations and times of events at this location, allowed for the reconstruction using modern methods of channel hydraulics.

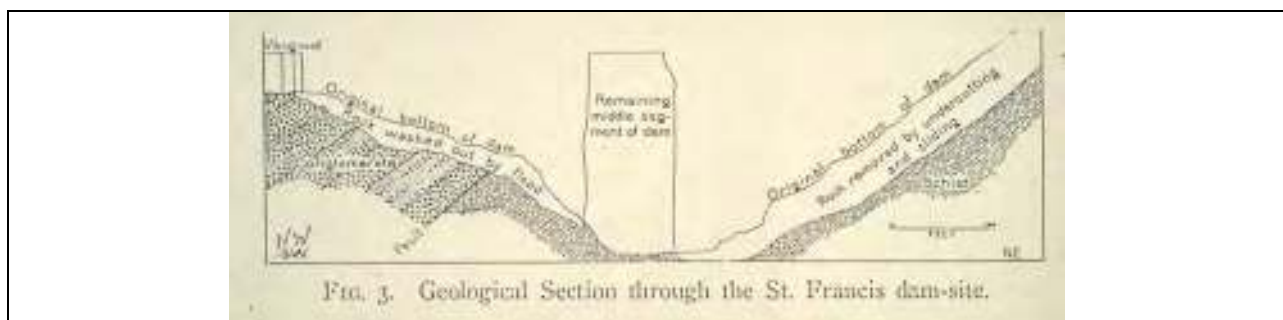
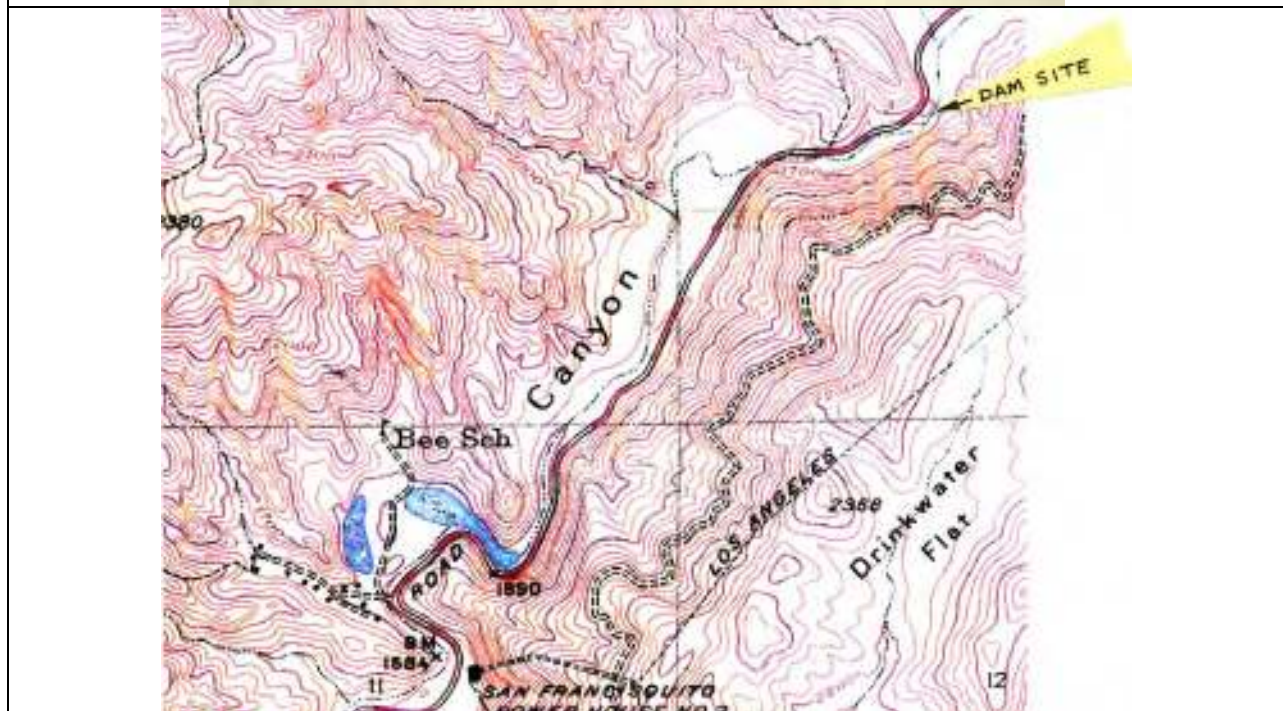
Figure 35. Upper – An outbreak flood hydrograph could not be estimated for the dam site initially, because the cross sectional area of flow would have been changing each second that side slope debris and portions of the dam were removed by the outpouring reservoir water (from Ransome, 1928). Lower - Portion of the Red Mountain 6-minute quadrangle released in 1936 which includes the St. Francis Dam site and DWP Powerhouse 2. This map was used in the forensic reconstructions of the outbreak flood hydrograph. The two lakes upstream of the powerhouse were filled by the city in 1952.

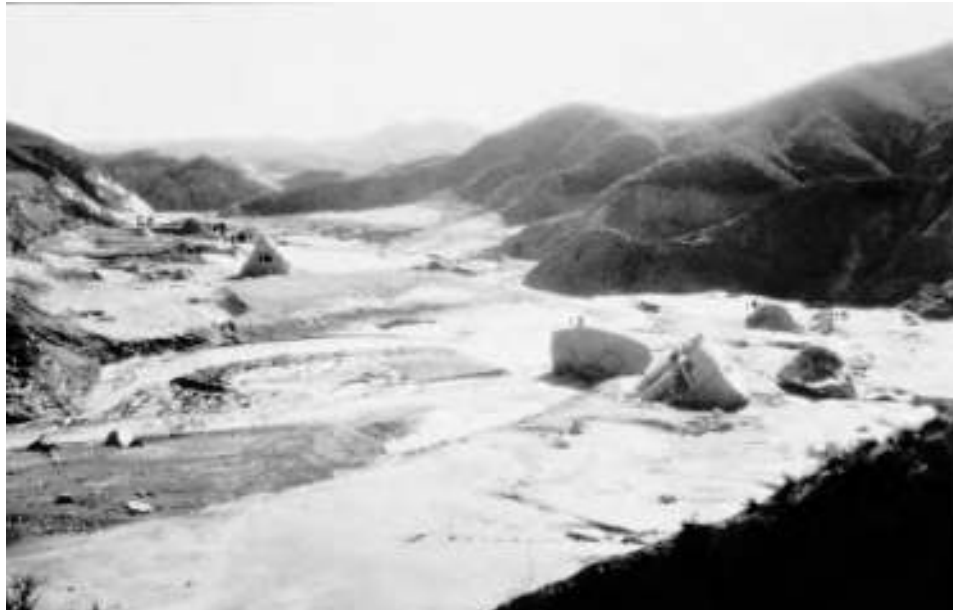
Figure 36. Displaced blocks of the dam, as viewed from a position about 1,000 feet downstream of the dam site. The block numbers written on the photo are those of the State Board of Inquiry (Fig. 38). Although Blocks 12 and 14 came from the base of the left abutment, they were situated between 22 and 26 feet higher than Block 16, seen further downstream and within the low flow channel.

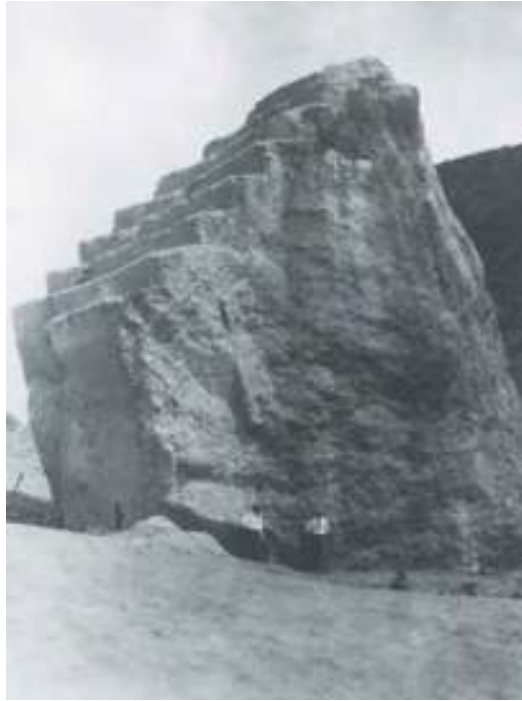
Figure 37. Close-up view of Block 16 (State designation) or 44 (BWWS designation), at 10,000 tons, the largest of the dam's displaced blocks. It was found about 1,500 feet downstream of the dam. The only plausible mechanism by which such a large block could be hydraulically transported would be by saltation in a dense slurry, akin to a massive debris flow. Photo from the Lee Collection, U.C. Water Resources Center Archives.

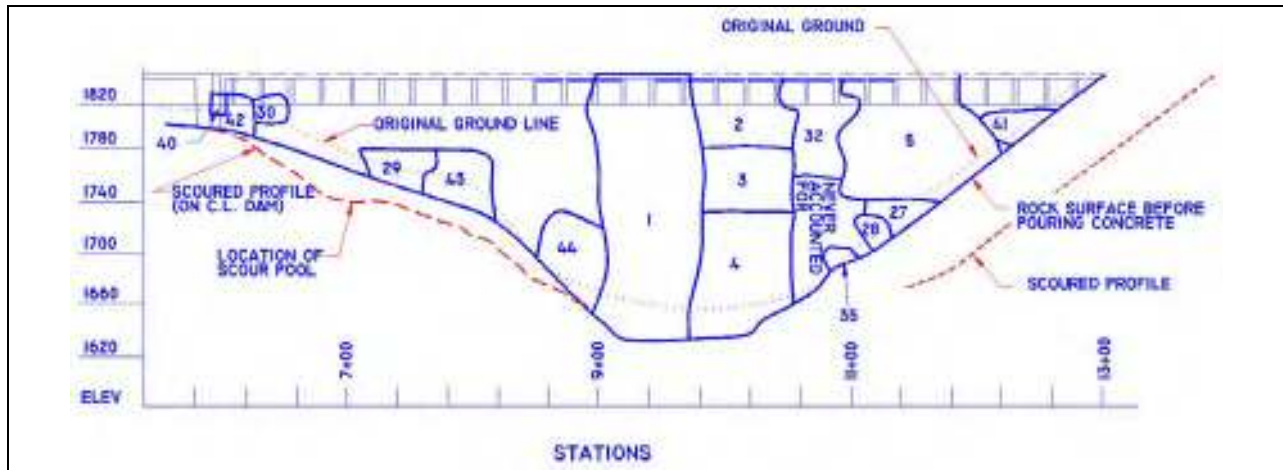
Figure 39. Upstream elevation view of the St. Francis Dam showing blocks positively identified by Charles Lee and Ralph Proctor, during surveys performed in March, April and May 1928. Note that many of the block designations differ from those presented in the State report, shown in the previous figure.

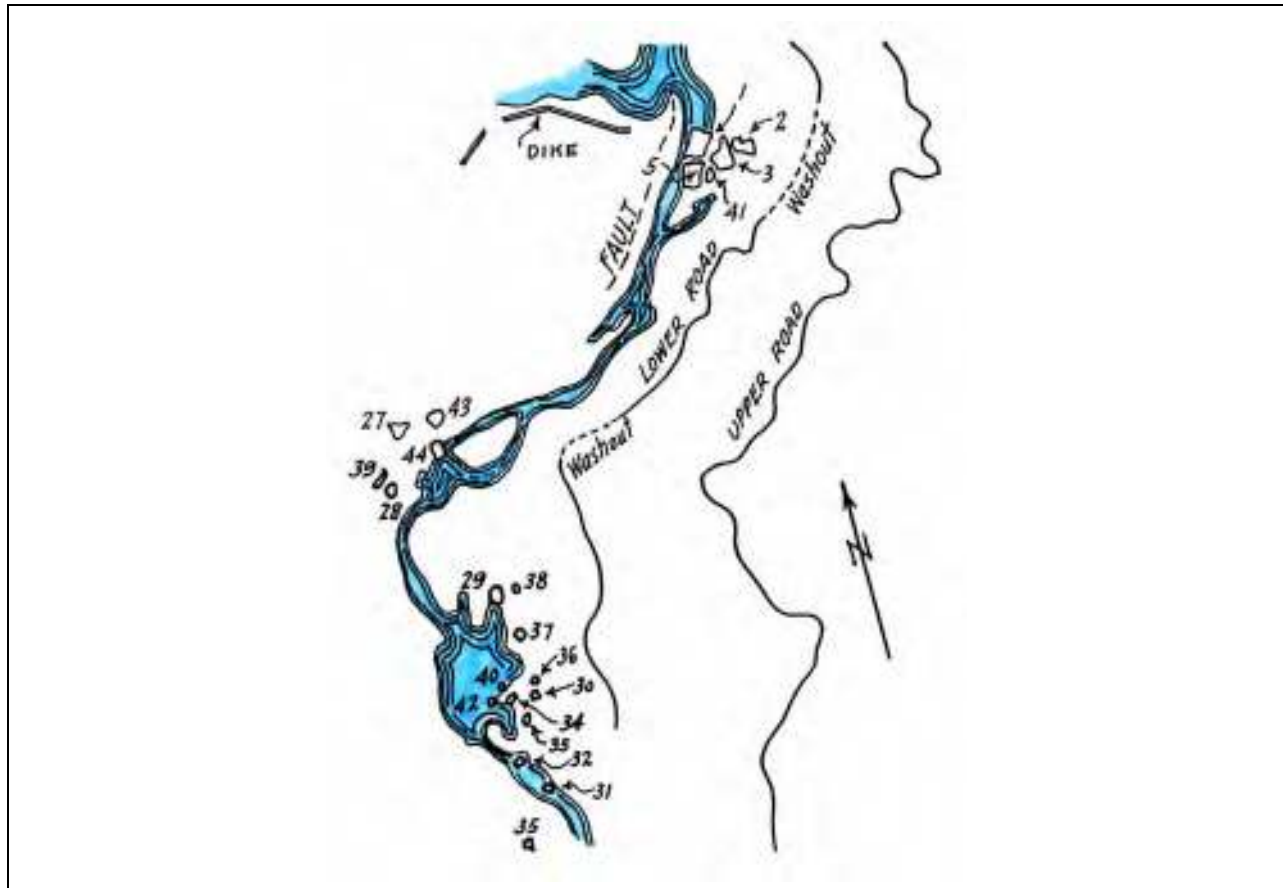
Figure 40. Plan view of the dam's displaced blocks determined by Lee and Proctor. This figure is an overlay of an annotated aerial photograph, and is not spatially corrected for parallax distortion on the photo. Of interest are the positions of Blocks 32 and 35, from the missing section on the left abutment, found furthest downstream.

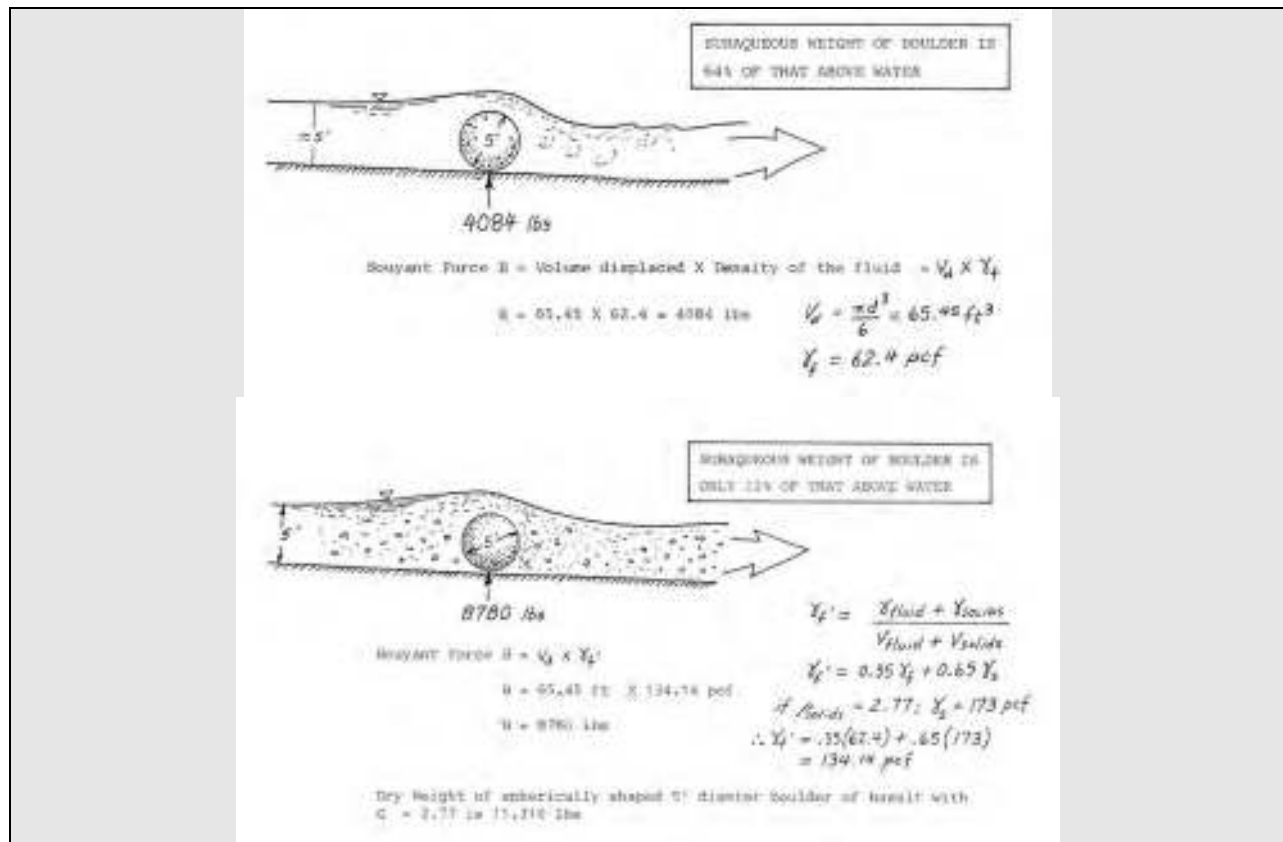
**Archimedes Principle and the transport of heavy objects in dense fluids.** The *subaqueous weight* of the dam's concrete blocks would have been reduced in proportion to the *bulk density* of the outbreak flood slurry surrounding them. In the upper diagram the uplift force engendered by clear water reduces the weight of the block to 64% of its dry weight. The lower diagram shows that a fluid with 65% entrained solids would further reduce the block's submerged weight, to just 22% of its dry weight. Debris flows slurries containing significant mica tend to entrain higher proportions of solids because the platy mica particles remain in suspension.

The answer lies in realizing the density of the outflow was extremely turbid because of two unique factors: 1) the introduction of 550,000 cubic yards of disaggregated schist available for hydraulic transport from the left abutment landslide; and 2) the propensity of the schist to remain in suspension when contained in a slurry, such as a debris flow (Rodine and Johnson, 1976). If 38,000 acre feet of water eroded between 600,000 and 800,000 cubic yards of debris at the dam site, that would only represent between 1 to 1.3% entrained sediment, overall. But, the initial flood surge, cutting through an enormous gap formed by the east abutment landslide, must have been supercharged with sediment, because over half a million cubic yards of material was swept away in about five minutes.
