# **The 1928 St. Francis Dam Failure and Its Impact on American Civil Engineering**

*J. David Rogers*

## **THE 1928 ST. FRANCIS DAM DISASTER**

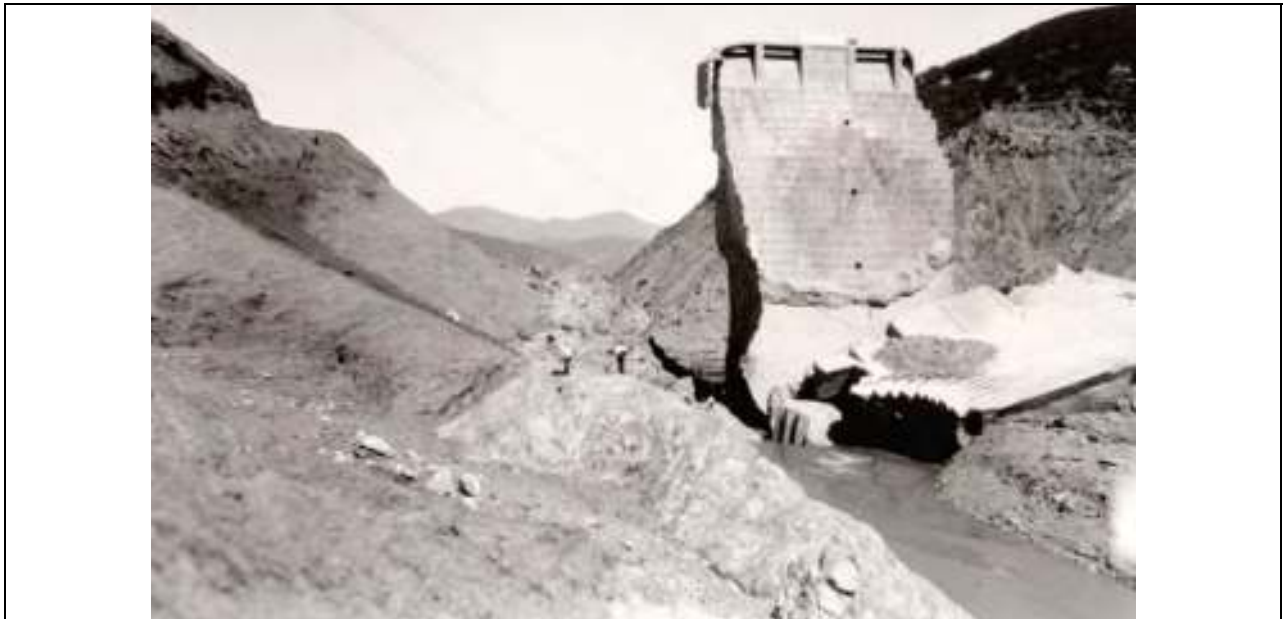
Figure 41. View of San Francisquito fault contact, between the Vasquez sandstone (at left) and Pelona schist (center of image), as viewed looking upstream at the dam's right abutment. Note the graphic nature of the contact, planed off by the outpouring water. Also, note the downed SCE power lines, trending towards the east abutment slide, out of view to the right. These lines were clipped before the Governor's Board of Inquiry visited the dam site (from Lippincott Collection of the U.C. Water Resources Center Archives).

Professor Louderback was particularly critical of the dam's placement directly across the San Francisquito fault (see California, 1928, pp. 10-13; and Louderback, 1928). The stark nature of the faulted contact between the Vasquez formation conglomerate and the Pelona Schist scoured clean by the outpouring waters of the reservoir can be appreciated in Fig. 41. Ransome appears to have been more critical of the Vasquez formation's (then called the Sespe formation) tendency to swell and to slake upon submersion, due to some of its beds containing gypsum. In the aftermath of the dam's failure a favorite ploy of prosecuting attorneys attacking Mulholland and the city was to drop a piece of this arkosic sandstone into a glass of water and watch it disintegrate (in the wrongful death suits brought against the city by BWWS Powerhouse 2 survivor Ray Rising, who lost his wife and children; see Davis, 1993, p. 251). The formal recognition of slaking and development of a standard to test for it were not developed until the late 1930s, during work on the MWD Colorado River Aqueduct.

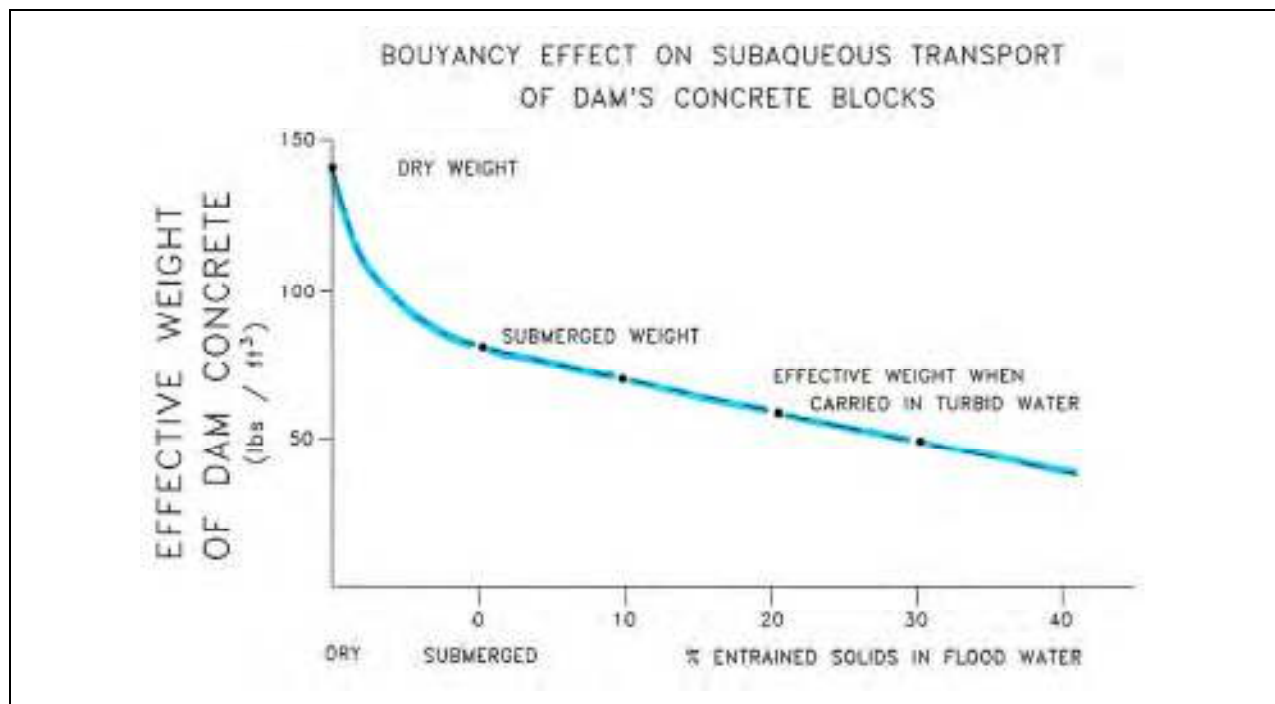
Figure 42. Relationship between effective weight of the dam's concrete blocks and the turbidity of outflow. Slurries developed in debris flows emanating from the Pelona Schist have been documented with between 65% and 85% entrained solids.

Destructive debris flows in Wrightwood, California periodically occur along Sheep Creek and Heath Creek, channels which emanate from the Pelona Schist, on the same (southwest) side of the San Andreas fault, about 50 miles southeast of San Francisquito Canyon. Work on these debris flows (Sharp and Nobles, 1953; Morton and Campbell, 1974; Morton, Campbell, et al, 1979) has shown that slurries containing between 65% and 85% entrained solids have been documented (Rogers, 1984; Johnson, 1996). These unusually high values are ascribable to the mica content of the slurries (Johnson, 1970), which promotes dispersion. When the dam's concrete blocks were submerged in clean water, their effective weight would be diminished through simple buoyancy: their weight would be reduced by the amount of their dry weight minus the weight of fluid displaced. This would correspond to a decrease from 143 pcf to 80.6 pcf, as shown in Fig. 42. If we consider the turbidity of the outbreak flood, the block's effective submerged weight would be progressively diminished, described in the sidebar below and in Fig. 42. This is how debris flow slurries fright such enormous volumes of coarse clastic debris.

If the initial flood wave emanating from a landslide breach of the left abutment did occur, it is conceivable that the percent entrained solids would have been something between 20% and 65%, possibly even higher at the flow snout, which tends to form as the trailing debris has less flow friction to overcome about it's wetted perimeter. As a consequence, the trailing slurry moves faster, building up a steep-faced flow snout (see sidebar discussion). A slurry with 65% entrained solids would reduce the weight of the 10,000 ton block to just 2,000 tons, as shown in Fig. 42. It is likely that these large blocks were freighted downstream via saltation, within dense, fast-moving debris slurry.

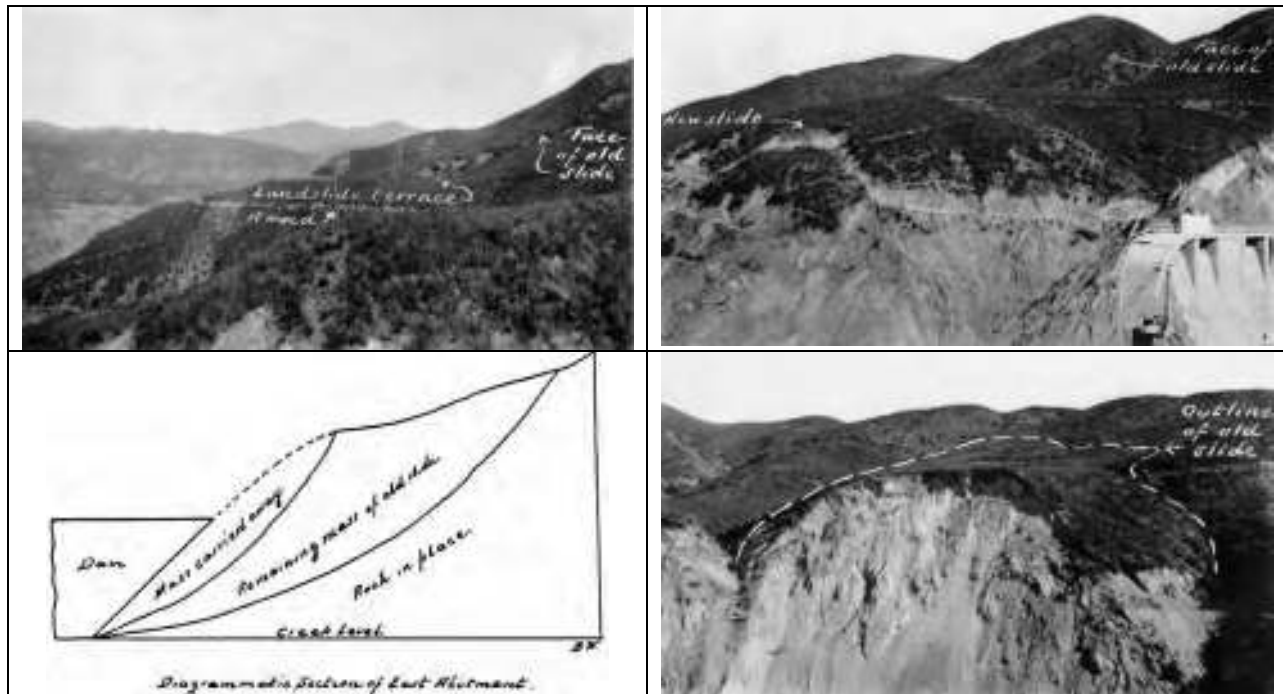
Figure 43. Some of the key figures from Willis June 1925 article in Western Construction News. The upper left image shows the old landslide terrace developed in the Pelona Schist above the reservoir area. The image at upper right shows one of the landslides that slipped into the reservoir due to rapid drawdown. The lower images show a hypothesized cross section through the east abutment landslide (left), suggesting that most of the pre-existing bedrock slide forming the dam's left abutment was not mobilized in the failure (photos courtesy of the Grunsky family).

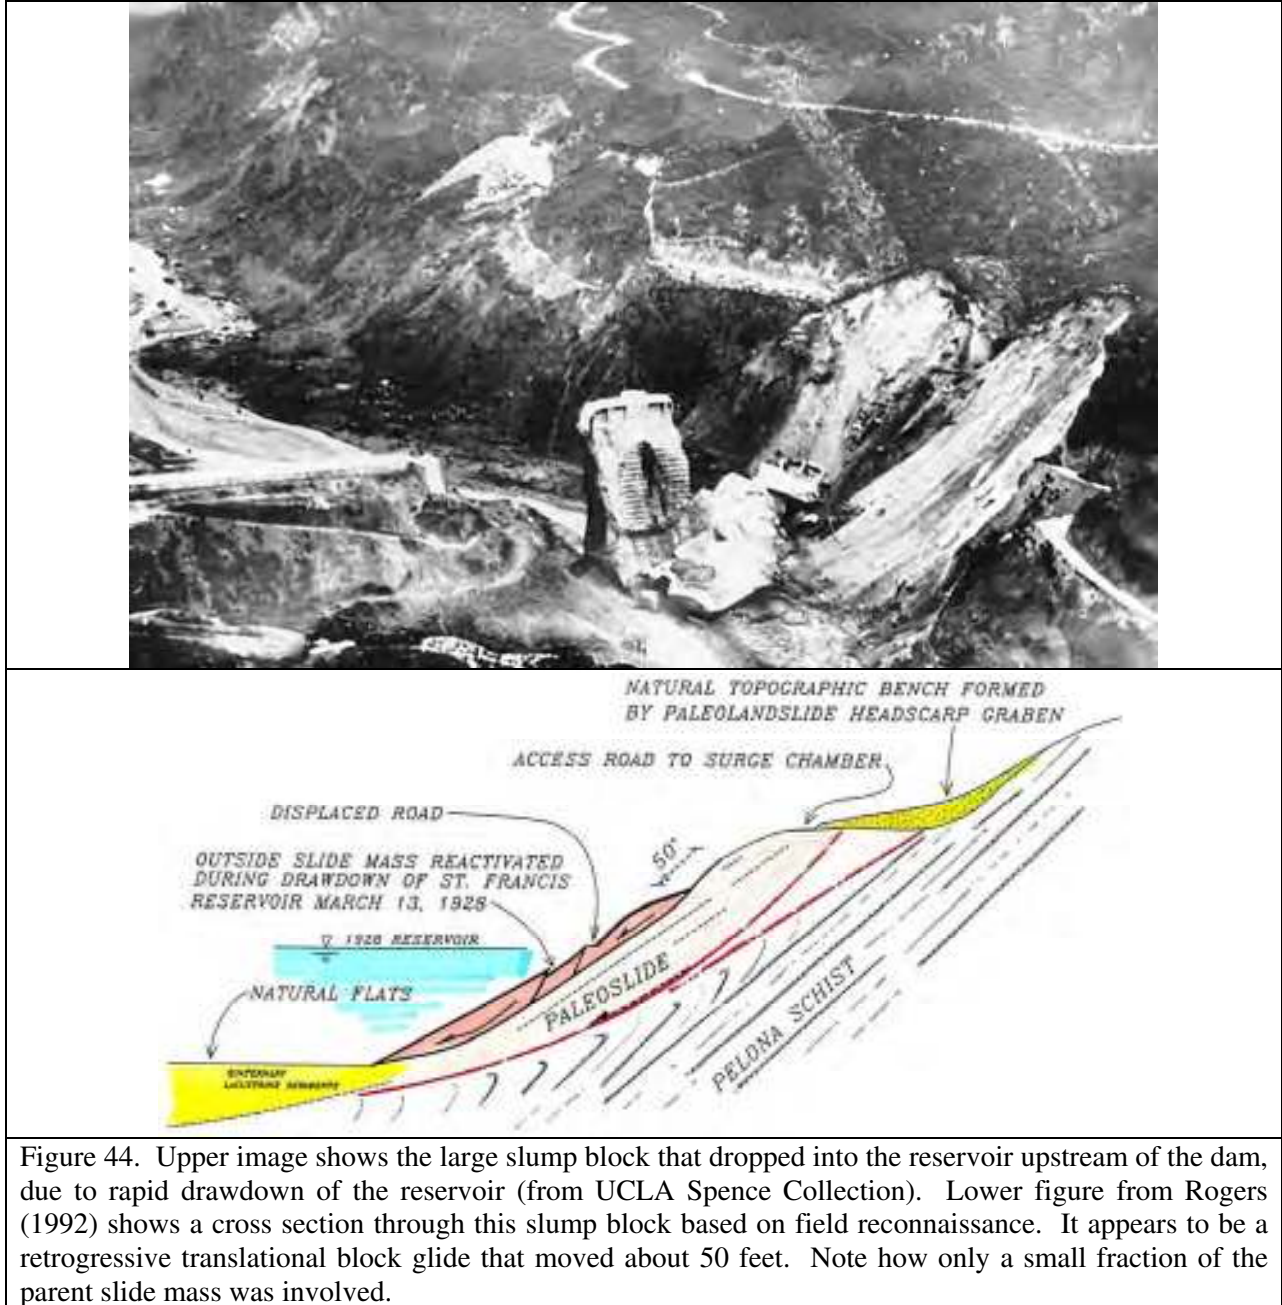
Figure 44. Upper image shows the large slump block that dropped into the reservoir upstream of the dam, due to rapid drawdown of the reservoir (from UCLA Spence Collection). Lower figure from Rogers (1992) shows a cross section through this slump block based on field reconnaissance. It appears to be a retrogressive translational block glide that moved about 50 feet. Note how only a small fraction of the parent slide mass was involved.

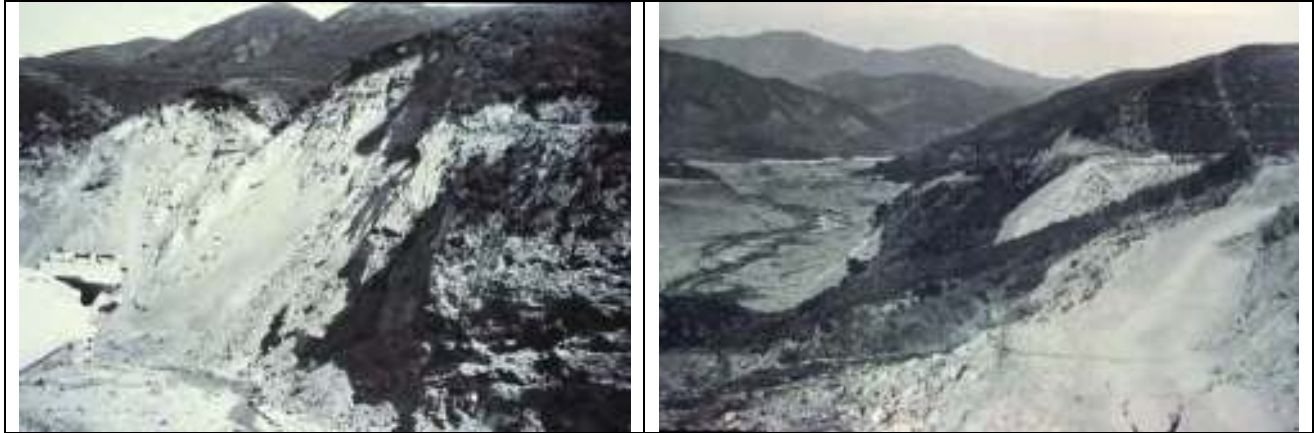
Figure 45. Left photo shows exposed scarp of the east abutment landslide extending well above old San Francisquito Cyn. Rd. Image at right shows gross ground deformations along the Bee Highline Road, about 300 feet above the dam's left abutment. The slope dropped two to nine feet above the east abutment slide. Both photos from Ventura County Museum of History & Art.

There is a good deal of physical evidence to support Willis' assertions. DWP's Bee Canyon power line road ran parallel to the reservoir's southeastern shoreline, about 300 feet above the valley floor (Figs. 28, 29, 44, and 45). Inspection of this road after the failure revealed large tension cracks at either end of a broad depression, about 300 feet above the dam's left abutment, as shown in Fig. 45 right. The entire slope appears to have dropped two to nine feet, well above the ragged headscarp of the east abutment slide.

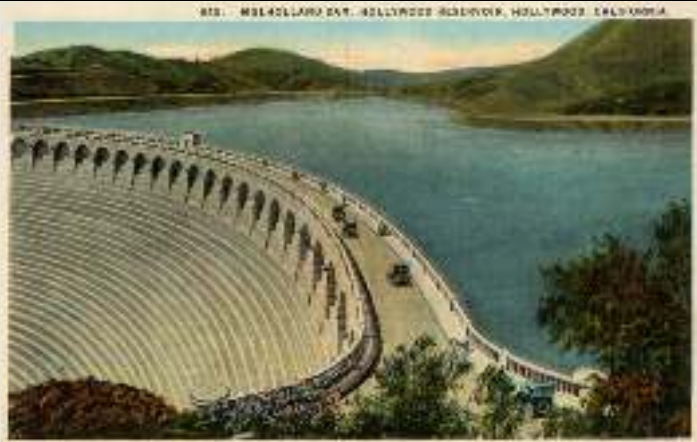
**Mulholland Dam was the sister structure and prototype for St. Francis Dam, completed a year earlier, in mid-1925. It retains Hollywood Reservoir.**

**Favorable topography for a dam.** To understand just how favorable the topography was for the St. Francis Dam site in San Francisquito Canyon, consider that the sister structure of the same height, Mulholland Dam, only retained 7,437 acre-feet of water; as compared to the 38,168 acre-feet retained by St. Francis. Both dams were ~200 feet high, but the exceedingly flat reservoir area in San Francisquito Canyon was created by the hydraulic choke afforded by the paleolandslides developed in the Pelona Schist and the structural control of the ancient San Francisquito fault. Topographically, it was a great place to put a dam.

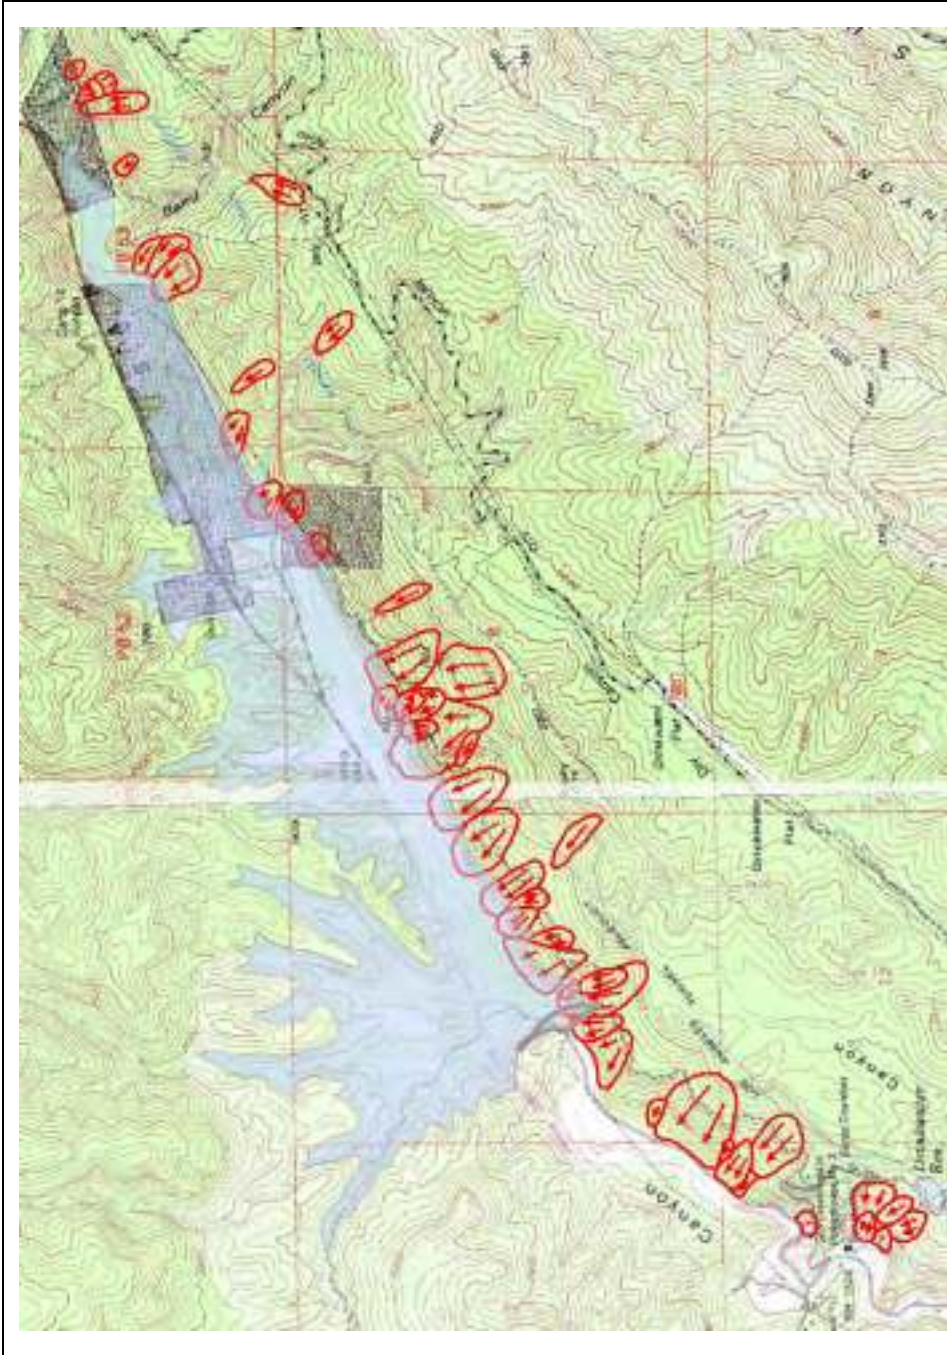
Figure 46. Landslide map of the St. Francis Dam and Reservoir area, overlain on the current USGS 24K quadrangles. The slides are developed in the Pelona Schist along inclined foliation, which averages about 35 degrees northwest. The ancient slides in the narrow, fault-controlled canyon blocked the channel and trapped sediment, creating the anomalous sediment filled glen that appeared topographically favourable for a storage reservoir. The age of the landslide dam is unknown, but there are some paleoflood outwash terrace deposits downstream of these slides, testifying to periodic floods of immense magnitude.

The many prominent terraces developed upon the Pelona escarpment (Fig. 10) can still be appreciated today (Figs. 42 and 43). As Willis deduced, these are not erosional terraces capped by terrace deposits, but colluvial-infilled headscarp grabens of enormous slump blocks, which slid upon the schist's micaceous foliation planes; just like the 1928 east abutment slide, but much larger. A landslide map created by the author and the late Perry Ehlig (see sidebar) is presented as Fig. 46.

The reason Bill Mulholland found the St. Francis site so topographically enticing for a reservoir was that it had previously been the scene of a paleolandslide dam-caused reservoir, much larger than St. Francis, at some time in the distant geologic past. A map showing recognized landslides developed within the Pelona Schist in vicinity of St. Francis Dam and reservoir is presented in Fig. 46. The dam site could be filled with a modest dam of just 130,000 cubic yards of concrete for a reservoir storing 38,000 ac-ft (see sidebar discussion, below). The reason the site possessed such favorable geometry for a dam was because it had repeatedly been the scene of a much larger dams and reservoirs, created by bedrock landslides that slumped into the canyon, blocking it. These occurred thousands of years previous to its exploration in the early 1900s. There is no mistaking the anomalous character of the flat alluvial-filled glens that typify the canyon just upstream of the dam site. The veneer of alluvium is likely underlain by clastic lacustrine sediments, overlain by low energy sediments, such as silt and clay.

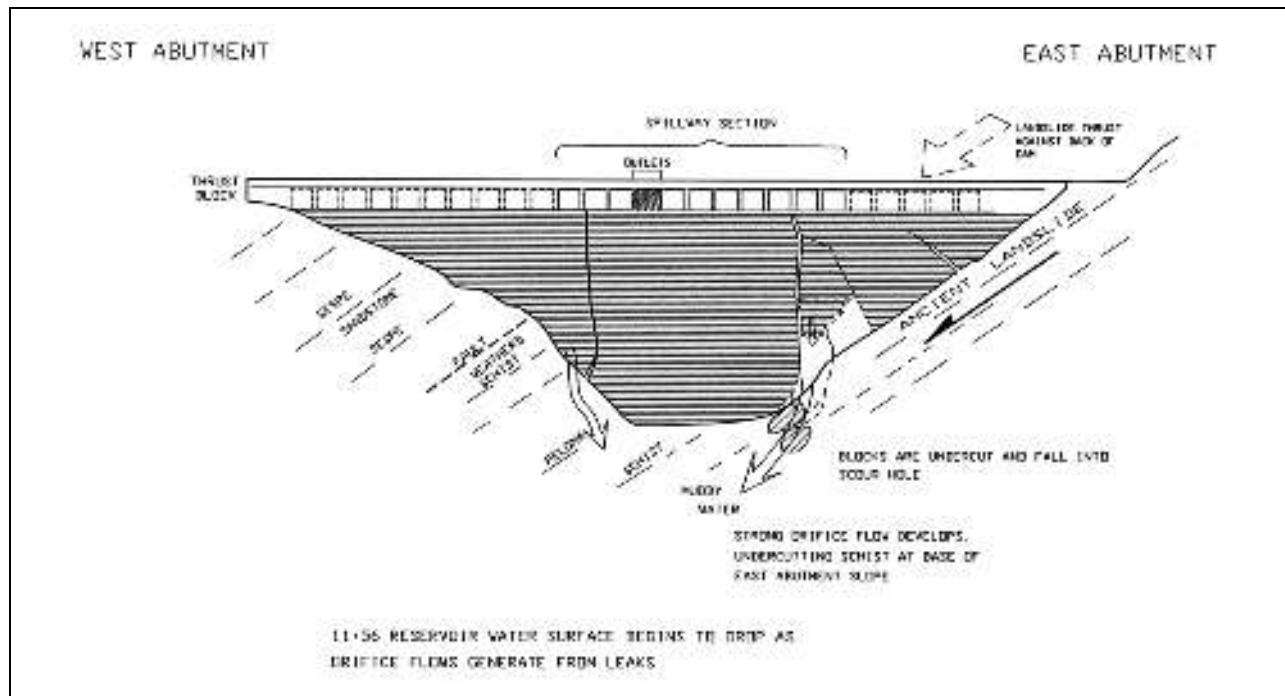
Figure 49. Schematic elevation view hypothesizing a precursory leakage at the base of the dam’s left abutment. The body of the damkeeper’s wife was later found at the base of the structure, and pieces of the dam from this area were carried furthest downstream.

significant thermal stresses and shrinkage of the mass concrete. 130,446 cubic yards of concrete were placed at St. Francis in just 16 months, without any attempt at cooling the concrete. As a consequence, some rather large contraction cracks formed in the monolith, which were plugged with oakum (dry wedges of oak wood, pounded into the cracks) in 1926-27 (those positions on the downstream face are portrayed in Fig. 49).

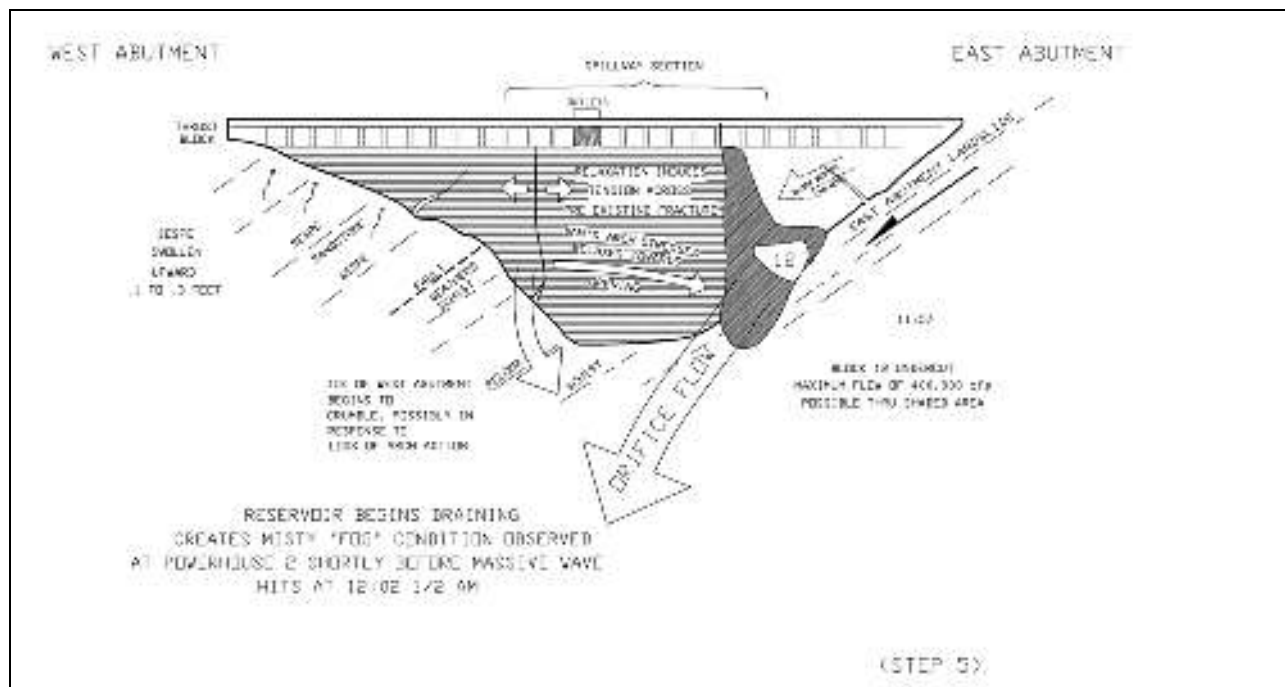
Figure 50. As the east abutment landslide mobilizes, Block 12 at base of the left abutment’s “missing section” is separated from the dam. Orifice flow at base of the left abutment slide may have created misty fog condition described by one of the Powerhouse 2 survivors.

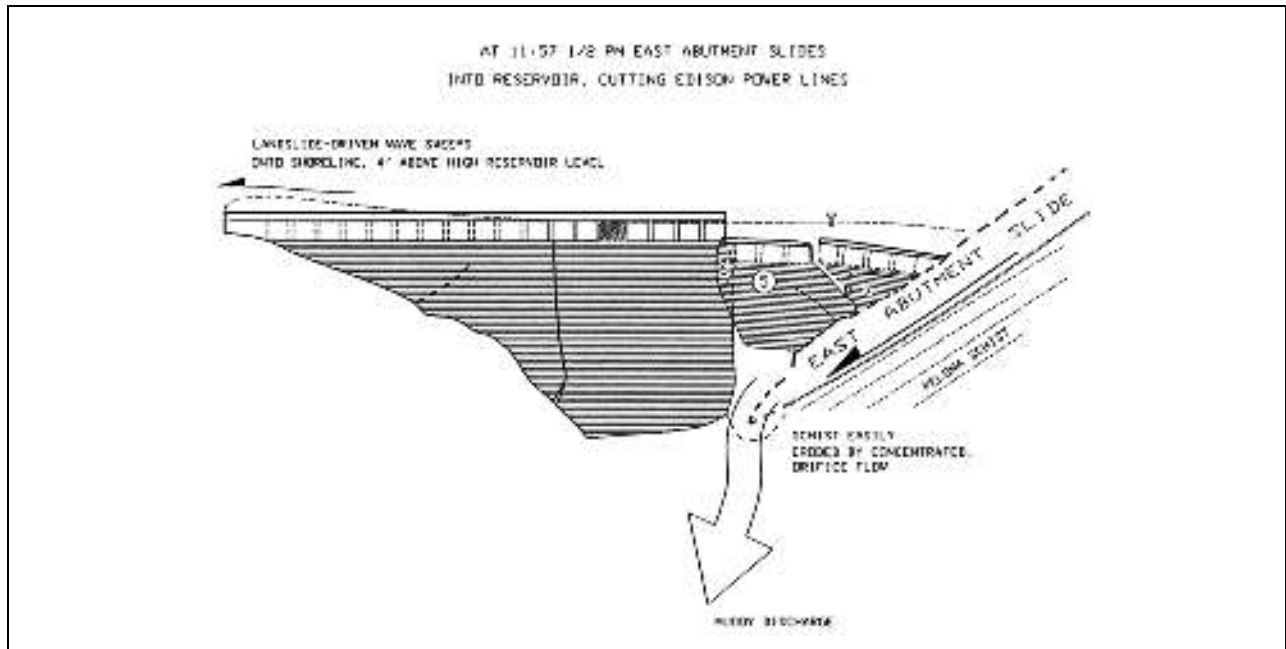
Figure 51. Schematic portrayal of the initial mobilization of the east abutment landslide, which severed power lines 90 feet above the dam crest on this abutment at 11:57-1/2 PM. A pile of flotsam was discovered the day after the failure washed 4 feet above the maximum pool level on the northwest shore of the former reservoir.

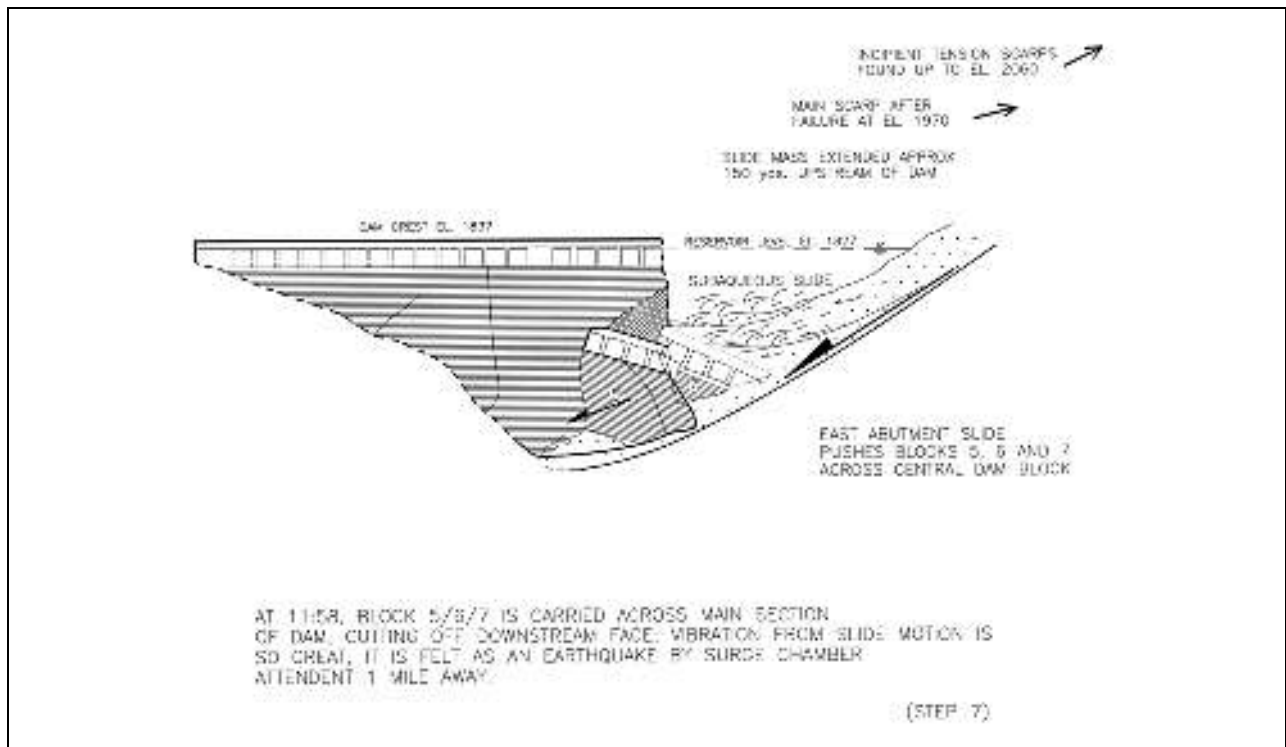
Figure 52. Schematic portrayal of the east abutment slide carrying Blocks 5/6/7 across the downstream face of the central dam core, shearing off about 10 feet of the dam's concrete on the stepped downstream face.

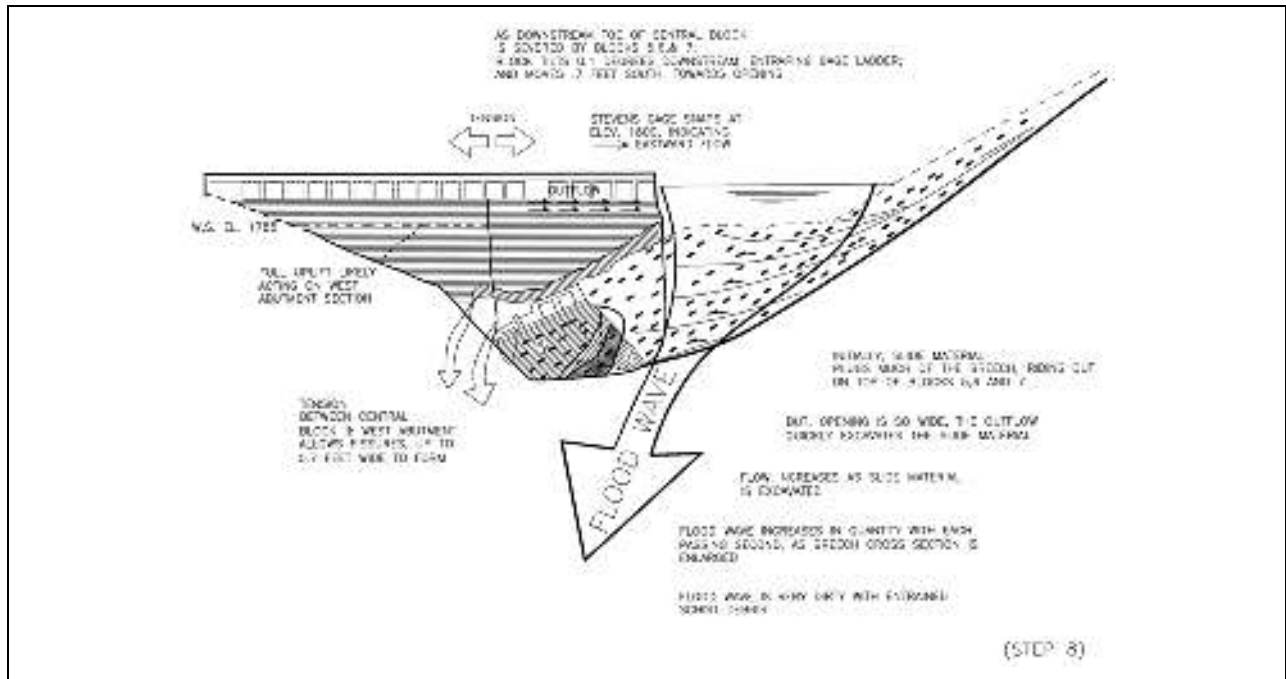
Figure 53. Schematic portrayal of the removal of the landslide debris dam created by the sudden mass movement of the east abutment slide, as a sort of quasi-subaqueous flow. The debris was a short-lived impedance to the outpouring waters. Note that Block 5 originally came to rest at a higher elevation, as noted by the chatter marks on Blocks 1 and 16.

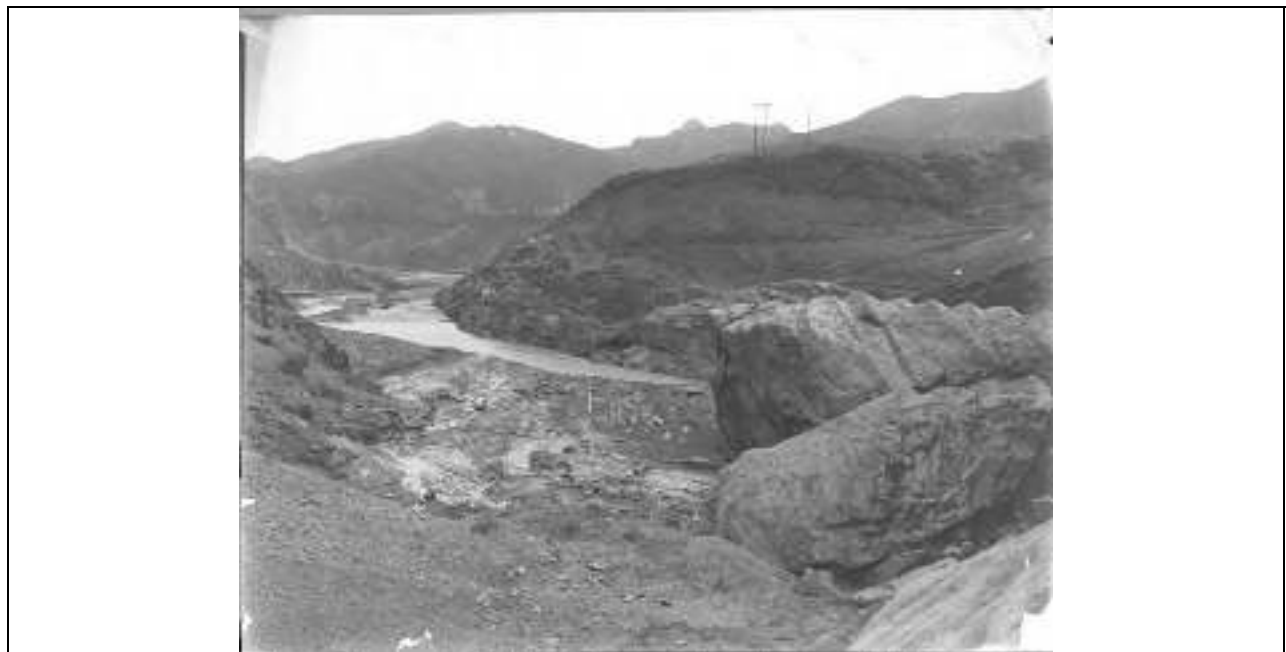
Figure 54. View from left abutment looking downstream at Block 7 wedged in behind Block 5. Note the accumulation of talus shed off the east abutment landslide scarp, which was 450 ft high. Photo by H. Wildey, from the author's collection.

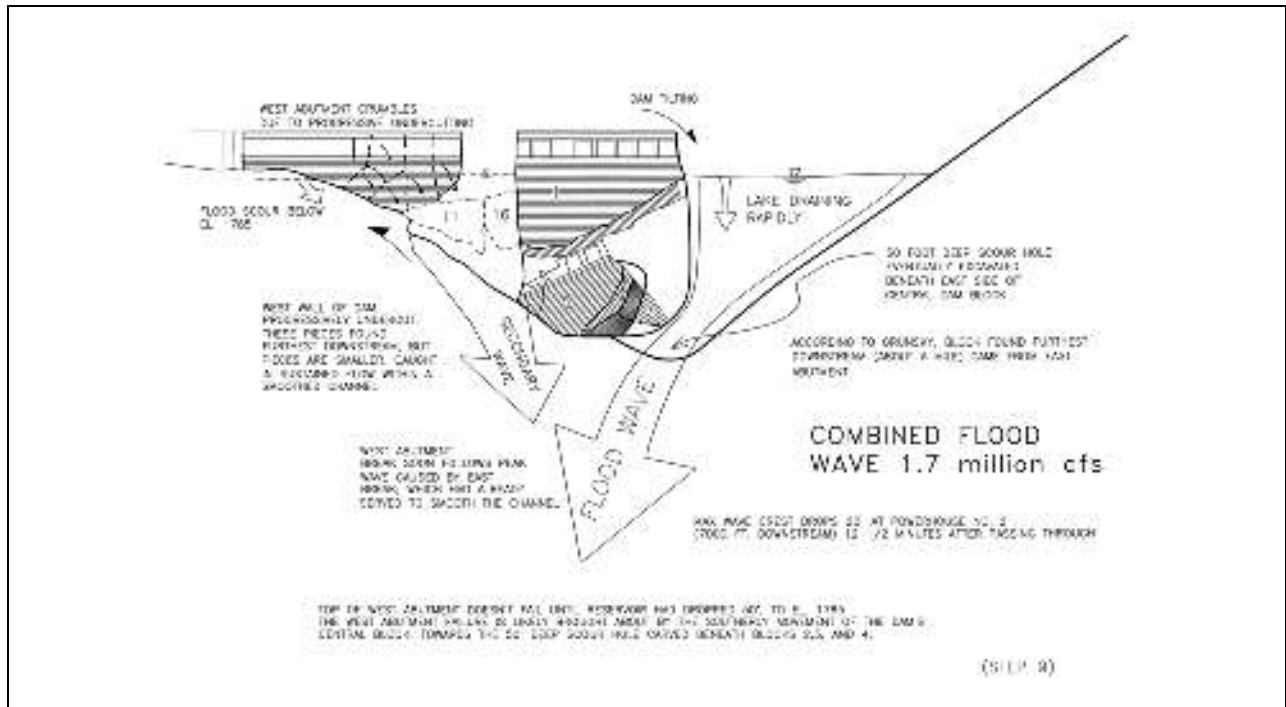
Figure 55. As the outpouring water removed more and more of the slide debris from the left side of the central core (Blocks 1 thru 4), the flow area increased (though hydraulic head was decreasing). This outpouring soon scoured beneath the core's left side, causing the core to tilt towards the expanding void. When this tilt occurred, there was a loss of arch stress transfer towards the right abutment, and this area began to break up along the pre-existing shrinkage crack bordering Block 1.

The reservoir was about two-thirds empty by the time the right abutment gave way, as evidenced by the low scour line on the right abutment (Fig.62). This section likely gave way as Block 1 moved towards the gap on the left abutment side, the motion increasing as the flood volume diminished, lessening the lateral restraint. That Blocks 16/44 and 11/43 were transported so far is likely ascribable to their having been carried on a bed of fluidized debris, which had been deposited by the left abutment landslide and protected where it had piled up on the upstream face of the right abutment (this is why the chatter marks on Blocks 1 and 16 were so far above the final position of Block 5). So, the right abutment blocks were carried away in a debris slurry which represented a secondary mobilization of what remained of the left abutment slide debris (Fig. 55).

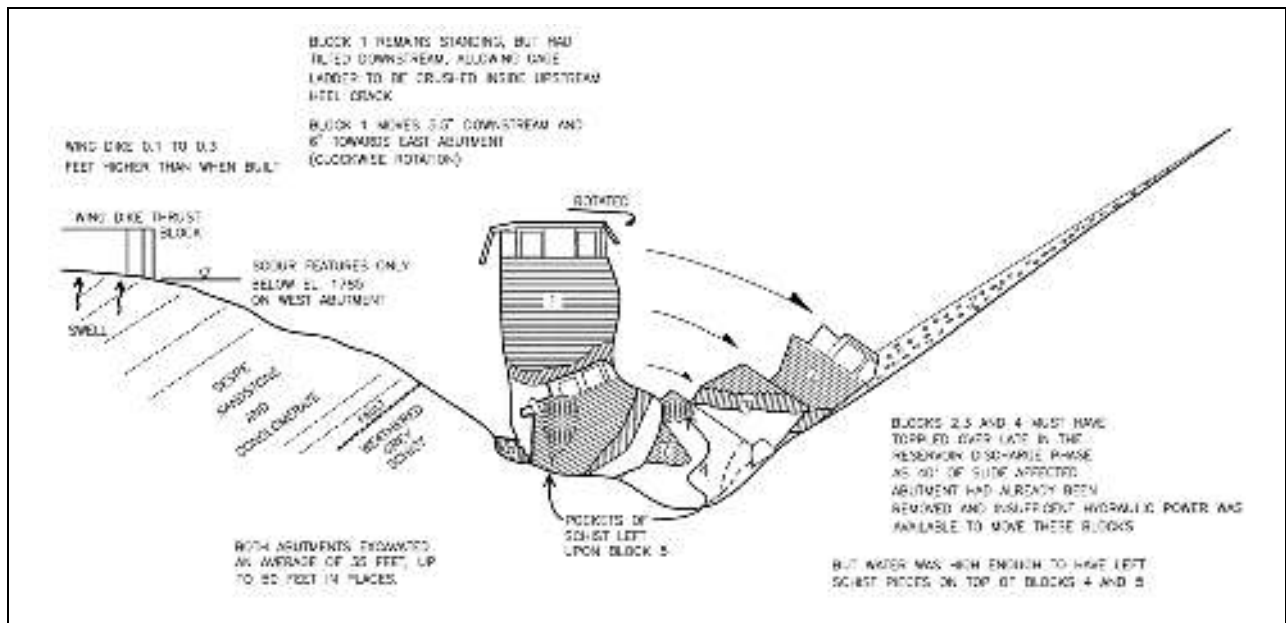
Figure 56. Schematic portrayal of the final stages of the St. Francis failure, when Block 2/3/4 fell backward, into the enormous hole scoured about the core block's left side. The left half of the dam's central core broke into three pieces as it rotated ~58° backward. All the dam's major pieces appear to have split along low strength horizontal pour joints because of low tensile strength of those horizons.

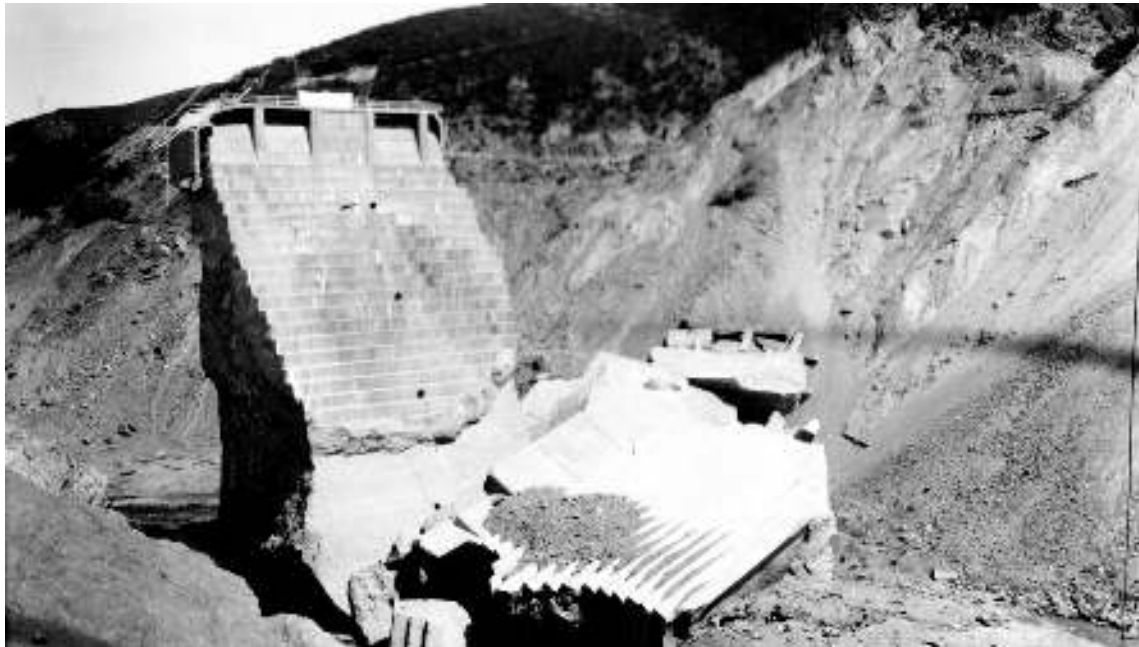
Figure 57. Upstream view of Block 5 sitting in front of Block 1 after the failure. Note the quantity of schist detritus sitting atop Block 5, testifying to its having been carried down slope in a slurry of disaggregated schist. Note the chatter marks on Block 1 cut by Block 5 and the latter's final resting position, about 30 feet lower. The material originally supporting Block 5 was likely swept away when the right abutment subsequently failed. Photo from the Lee collection, U.C. water Resources Center Archives.

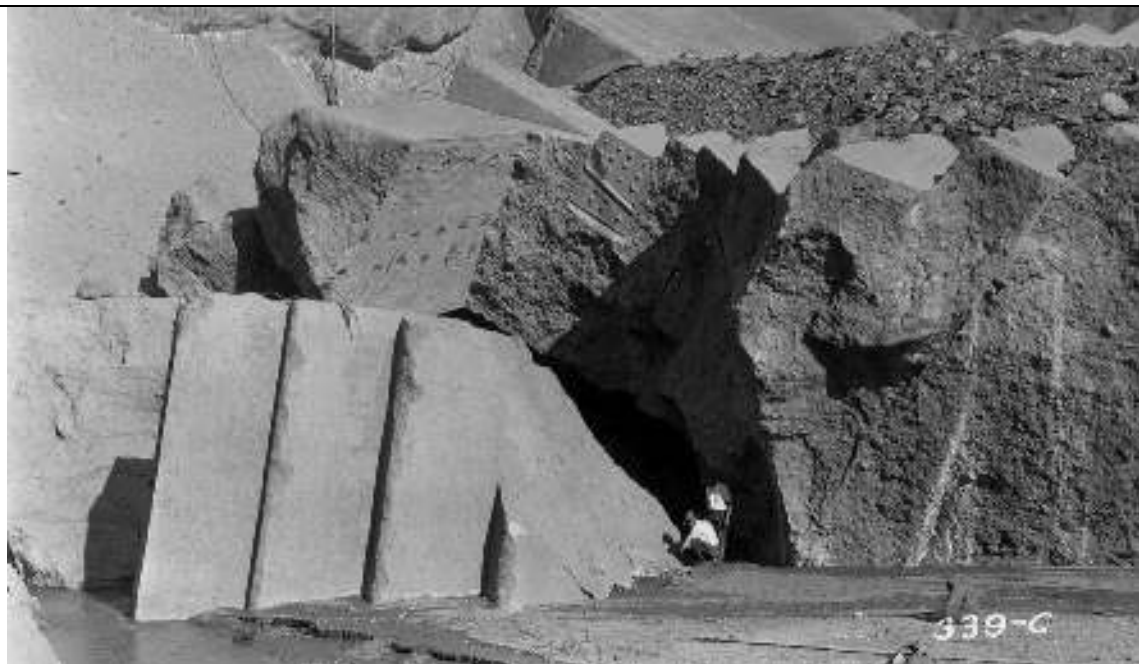
Figure 58. State survey party examining Block 6, which fell off of Block 5. Note the schist detritus infilling the 5 foot high steps of Block 5, 25 to 30 feet above the channel in foreground. Photo by H. Wildey, from author's collection.

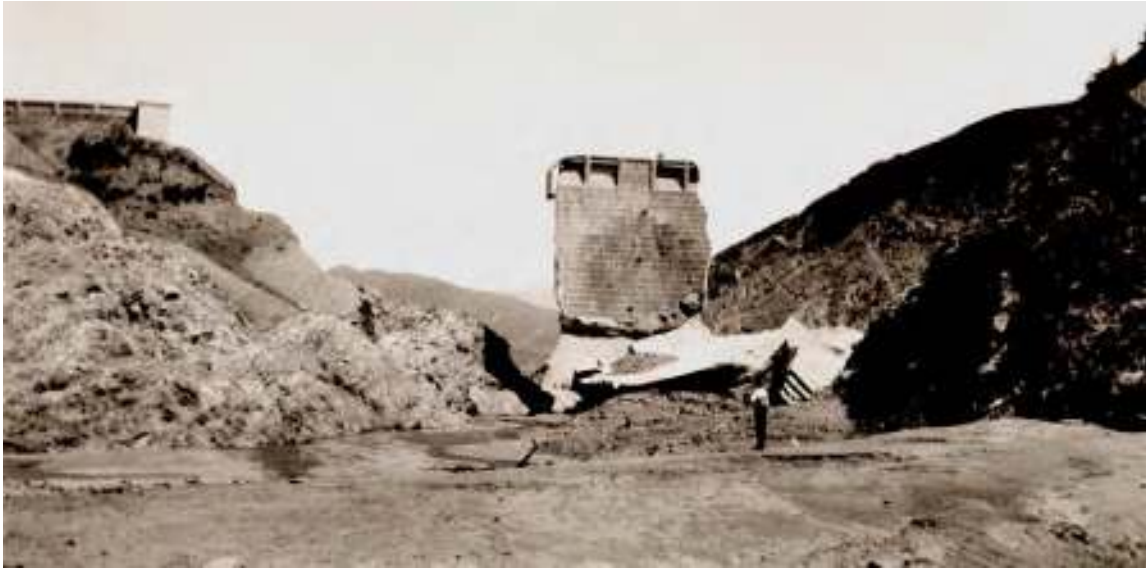
Figure 59. View looking upstream at the imposing monolith of Block 1. As in the previous photos, the gap between Block 5 and the chatter mark cut into Block 1 is noticeable, as is the clean character of the right abutment, swept clean of all debris in the later stages of the failure. Photo from the W.L. Huber Collection of the U.C. Water Resources Center Archives.

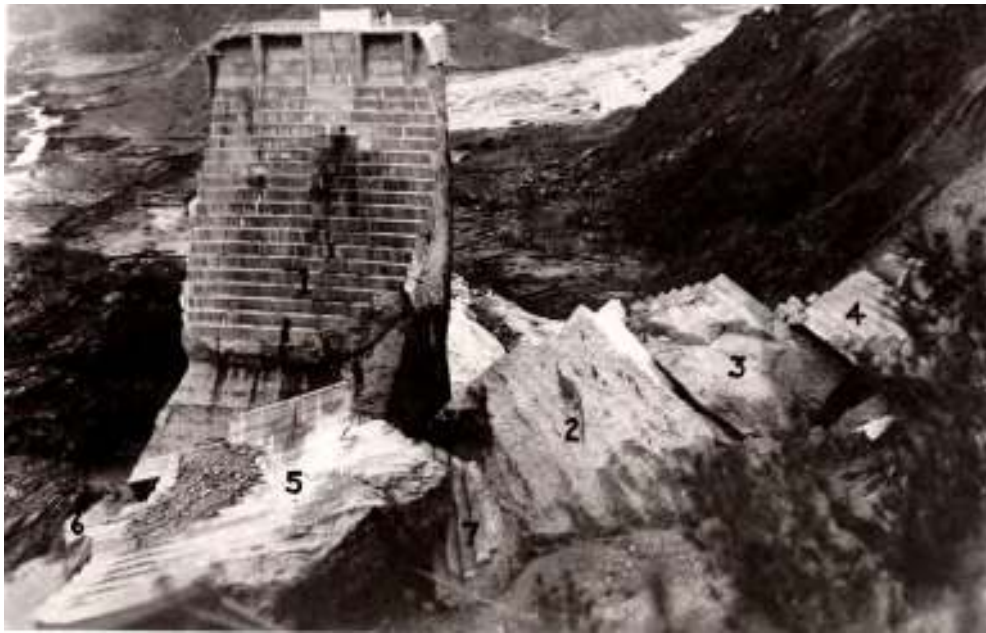
Figure 60. Upstream view of Blocks 1, 5 and 6 and those of Block 2, 3, 4, which rotated backward into a deep scour hole cut around the core's left side. Note the broken surface of Block 2 and most of Block 3, where the dam's downstream steps have been sheared off. Historian Charles Outland unravelled this puzzle while he was writing *Man Made Disaster* in the early 1960s. Photo from L.A. Dept. of Water & Power.

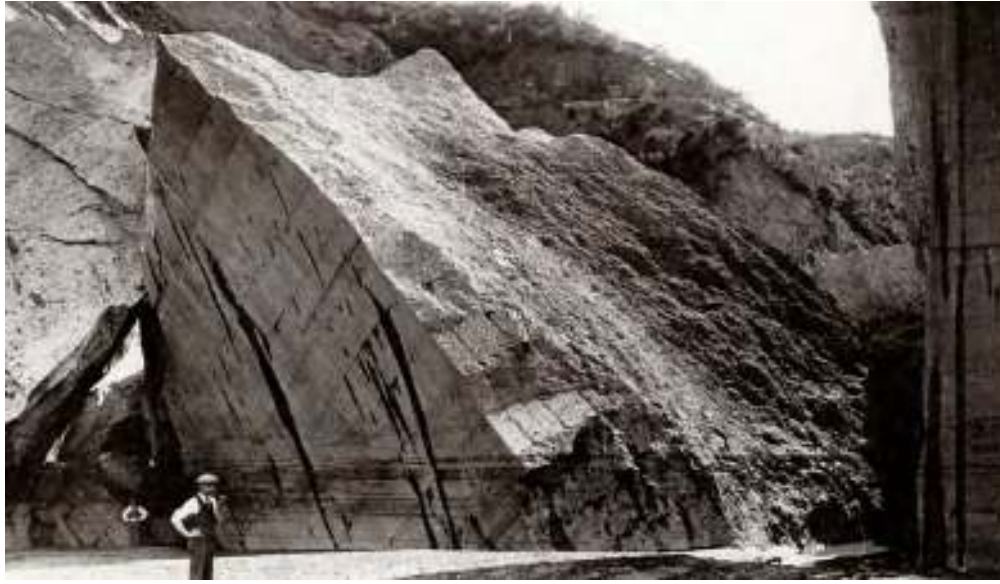
Figure 61. Ground view of Block 2 and a portion of 3, taken after the failure from upstream of Block 1. The horizontal scour marks across the inclined block testify to the reservoir stage when Block 2/3/4 toppled over. The reservoir was only about 17.5 feet deep, or nearly drained, when the left half of the dam's central core fell over. Photo from the W.L. Huber Collection of the U.C. Water Resources Center Archives.

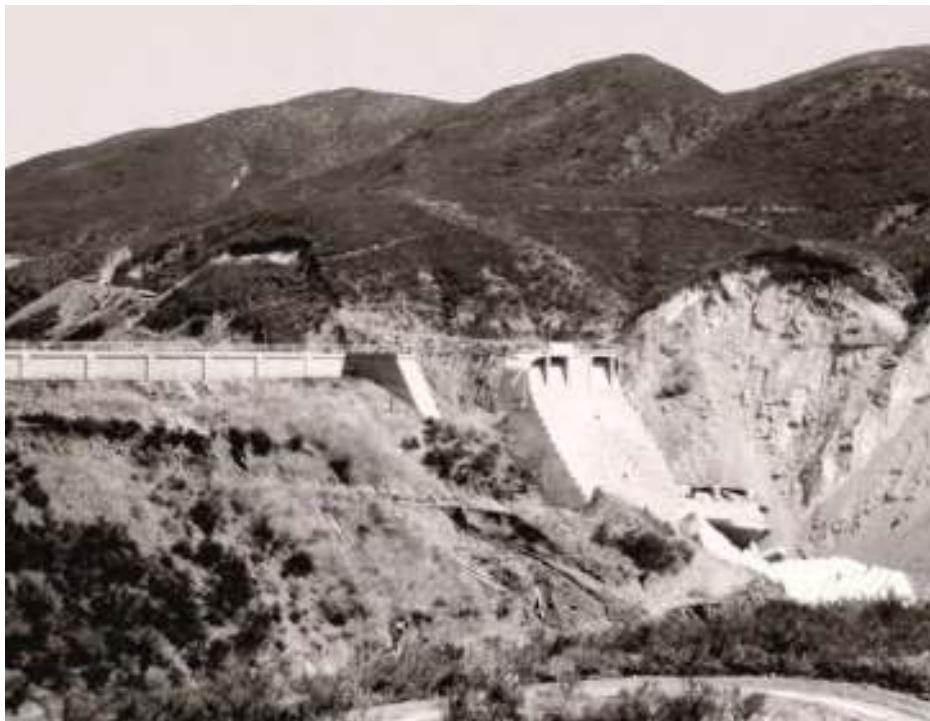
Figure 62. Ground view of the right abutment, just downstream of the dam following the failure. The intact nature of all vegetation on the dam's right abutment to an elevation at least 75 feet below the dam's crest suggests that the reservoir was 2/3 drained before the right abutment of the dam gave way (also see Fig. 29).
