# **The 1928 St. Francis Dam Failure and Its Impact on American Civil Engineering**

*J. David Rogers*

## **THE 1928 ST. FRANCIS DAM DISASTER**

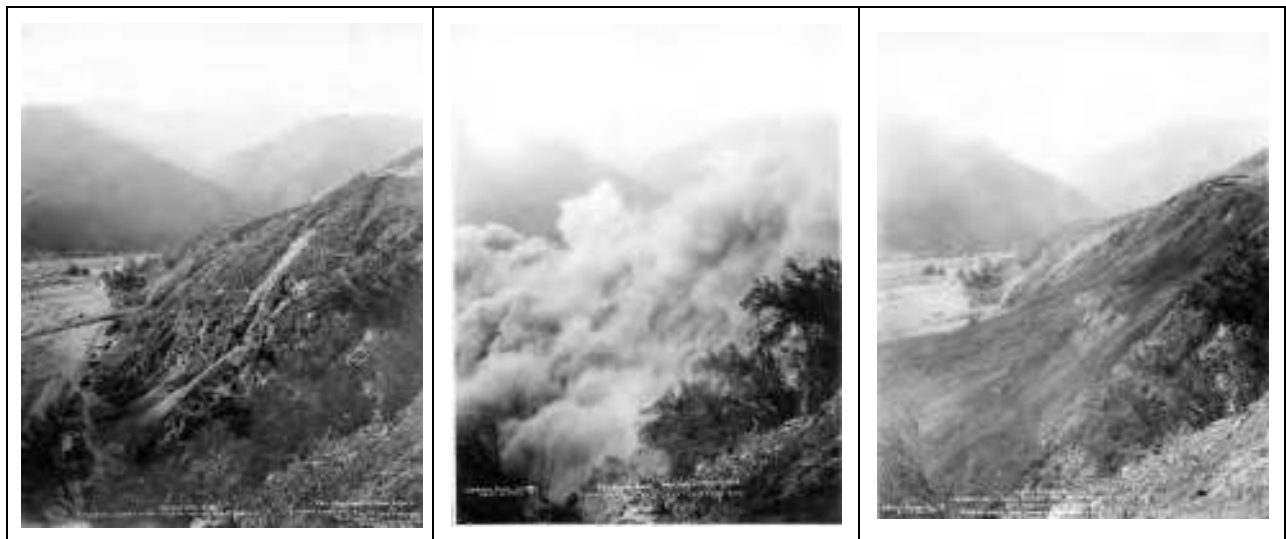
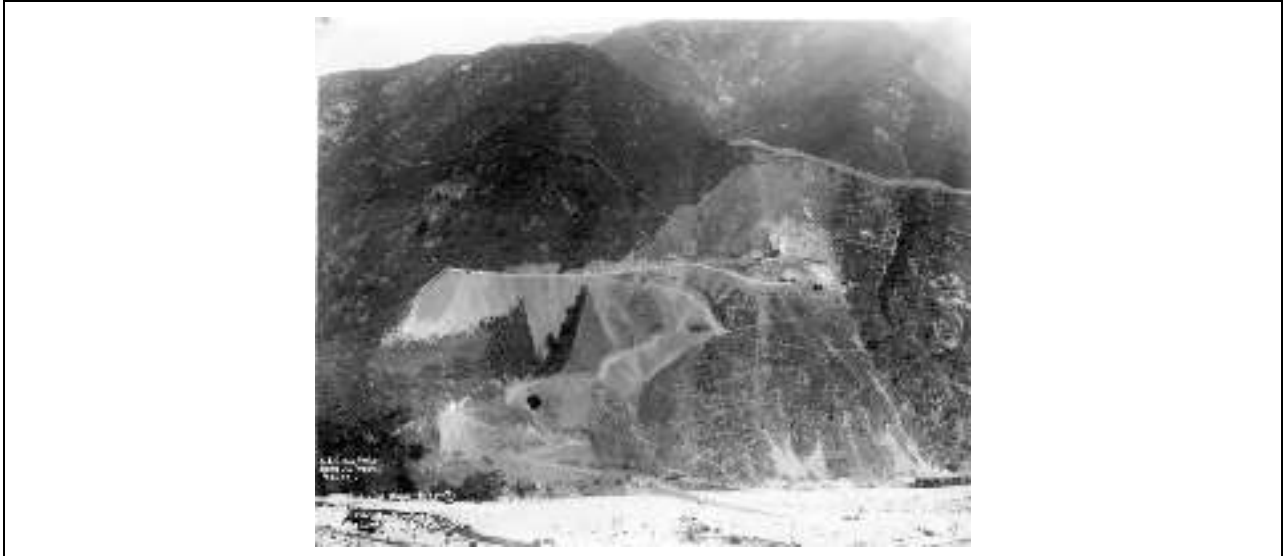
Figure 64. Ten times the size of St. Francis, San Gabriel Dam at The Forks site would have become the largest dam in the world if the State of California had not cancelled the project. This review authority over non-Federal dams by the state was established in the wake of the St. Francis disaster. These images show the excavation activities and landsliding that occurred on the right abutment in 1929. Photos from US Bureau of Reclamation.

The original San Gabriel Dam was intended to be a record breaker. It was laid out to be 500 feet high with a crest length of 2,300 feet and a concrete volume of 3.8 million yds<sup>3</sup> (even larger than Hoover Dam, completed 7 years later). The owner was the Los Angeles County Flood Control District, which had already spent \$3 million of the \$25 million contract, awarded in September 1928. During excavation of the dam's right abutment in June 1929, the contractor loaded coyote tunnels with 193,000 lbs of powder, bringing down 160,000 yds<sup>3</sup> of rock, but over-blasting the abutment left the rock severely fractured. On September 16<sup>th</sup> a massive landslide involving more than 200,000 yds<sup>3</sup> slid down into the canyon, halting further construction. The three images in upper panel of Fig. 64 show, from left, the right abutment before excavation, during the detonation in June 1929, and after the large rock slide in August 1929. The lower image in Fig. 64 is an elevation view looking at the right abutment before the blast of June 26, 1929.

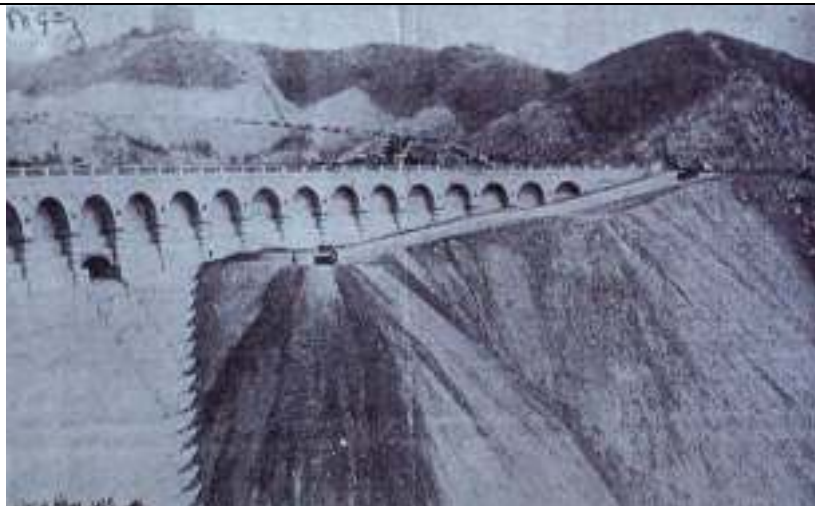
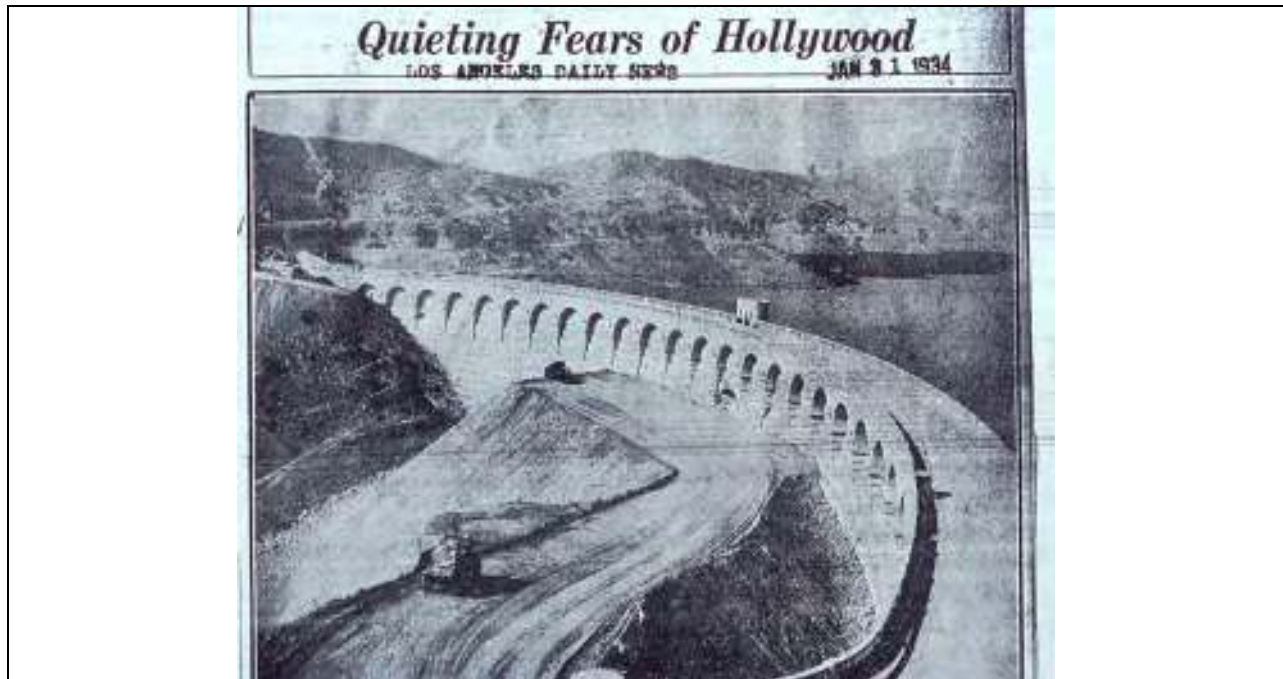
Figure 65. The sister structure to St. Francis, Mulholland Dam underwent a massive refit in early 1934, which saw the placement of 300,000 cubic yards of earthfill against its downstream face. In addition, the reservoir storage was curtailed 54%, from 7,437 to just 4,029 ac-ft of water. This reduced level was considered safe by the external review board. Images from the Municipal Reference Department at the Los Angeles City Library.

All of the review panels, even that chaired by BWWS's own Harvey Van Norman in 1930, concluded that Mulholland Dam had insufficient control of hydraulic uplift and underseepage to be stable in overturning under full reservoir pressure, more especially so, during an earthquake. They recommended drawing the reservoir down to elevation 715 feet, 36 feet below the dam crest, to bring the resultant thrust inside the middle third of the structure. The reservoir pool had been drawn down 50% in 1929 as a precaution to placate concerned Hollywood residents while the dam was analyzed. The Van Norman panel recommended placing an enormous earthen buttress against the dam's downstream face to heighten its safety factor against possible failure in the event of a major earthquake and placate public concerns.

After considering the increased stability engendered by the downstream embankment fill, the city concluded that the reservoir pool could be maintained no higher than 54% of the maximum level (4,028.7 ac-ft), and this is where it has remained since 1931. The reservoir is normally operated at a pool level between 715 and 721 feet, which is a conspicuous 35+ feet below the dam's crest elevation of 756 feet. In January and February of 1934 the City quietly supervised the placement of over 300,000 cubic yards of earth against the downstream face of Mulholland Dam to provide a massive buttress (Fig. 65). Today this slope is covered with eucalyptus trees, obscuring the concrete parapets of a once famous concrete dam that still bears the name of the City's famed waterworks engineer. Mulholland Dam retains Hollywood Reservoir, which local residents refer to as "Lake Hollywood."

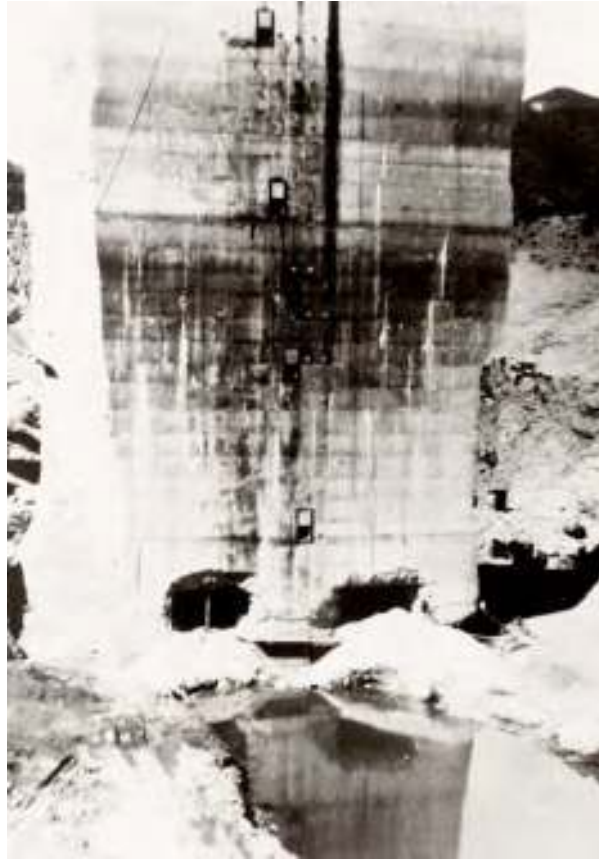
Figure 66. View looking at upstream heel of Block 1 in mid-1929, when the City was engaged in demolition work at the damsite. These adits in the upstream heel of Block 1 were loaded with dynamite and detonated, blowing the block backward, just like Blocks 2/3/4. Block 1 toppled backward and split into five discernable pieces. As in the case for Blocks 2/3/4, the concrete separated along undulatory cold pour joints, due to the weak tensile strength along these horizons, coated with a high water content laitance layer.

The City undertook demolition of the dam's recognizable pieces in the late summer of 1929, following the death of an 18-year old man who fell from Block 1 when his companion threw a rattlesnake at him (the victim's father watched from below). The father of the deceased sued the City. The demolition work appears to have been carried out by City public works crews, working with the City fire department. Dynamite charges were placed in holes jack-hammered into the concrete. Keystone Newsreels filmed some of the dike section being exploded, as well as excavation work on the upstream heel of Block 1, shown in Fig. 66.
